**Debris Flow Hazard Study
Micron Project
Approximately 500 West and State Road 92
Lehi, Utah**

GeoStrata Job No. 589-100
October 11, 2021

Debris Flow Hazard Study
DR Horton
Micron Project
Lehi, Utah
Project Number: 589-100
Site Vicinity Map

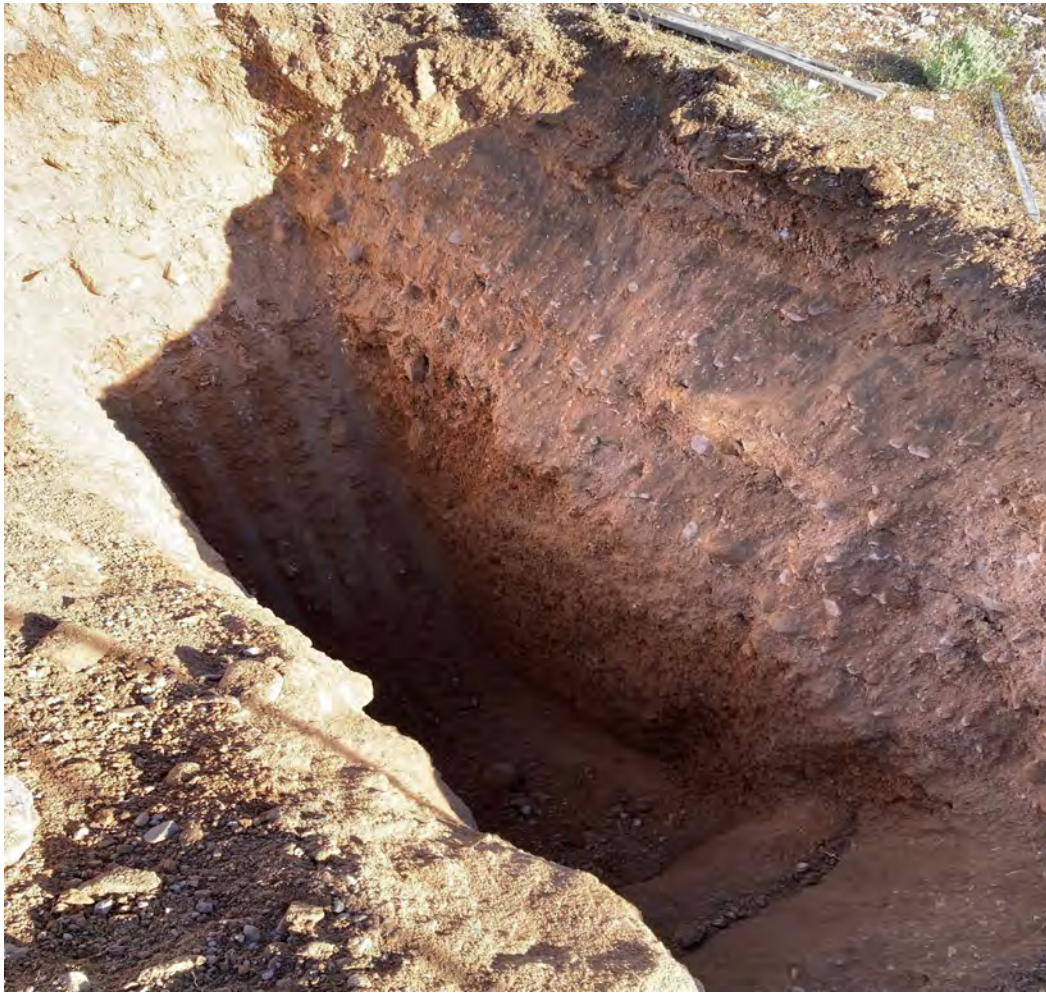
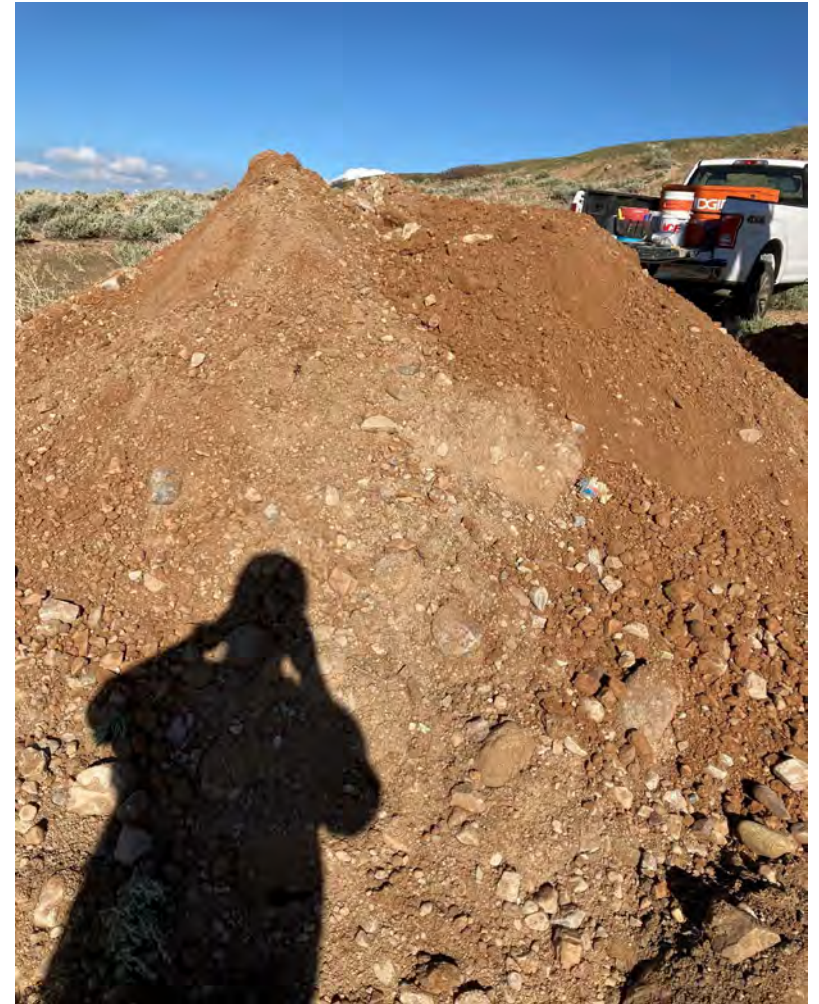
**Plate
B-39**

Test Pit 5 at 12' and Stockpile from Test Pit 5

Test pit DS-TP-05 is located west of the mouth of D6. Based on our observations, the Clayey GRAVEL (GC) observed in DS-TP-05 appear to be related to alluvial fan deposits. Cobbles greater than 4 inches in diameter were observed in this test pit.

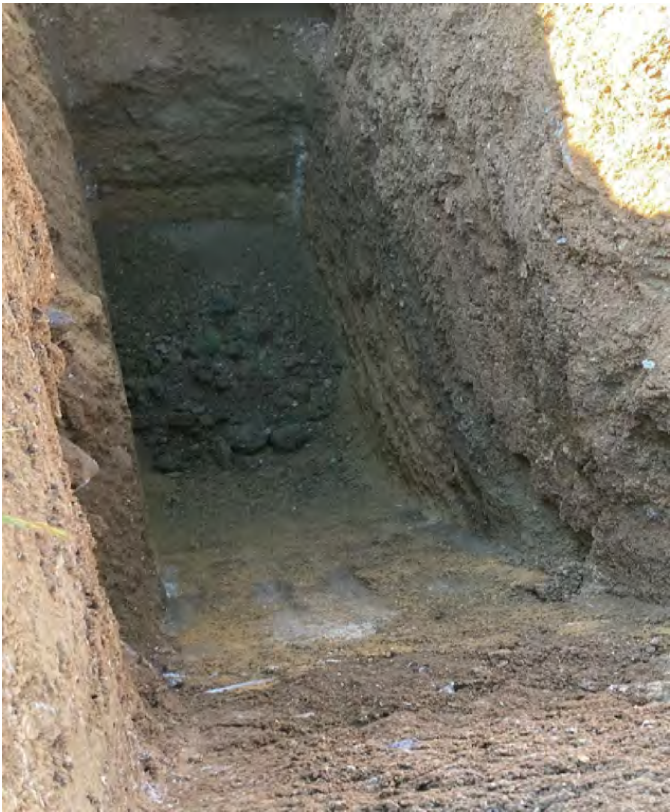
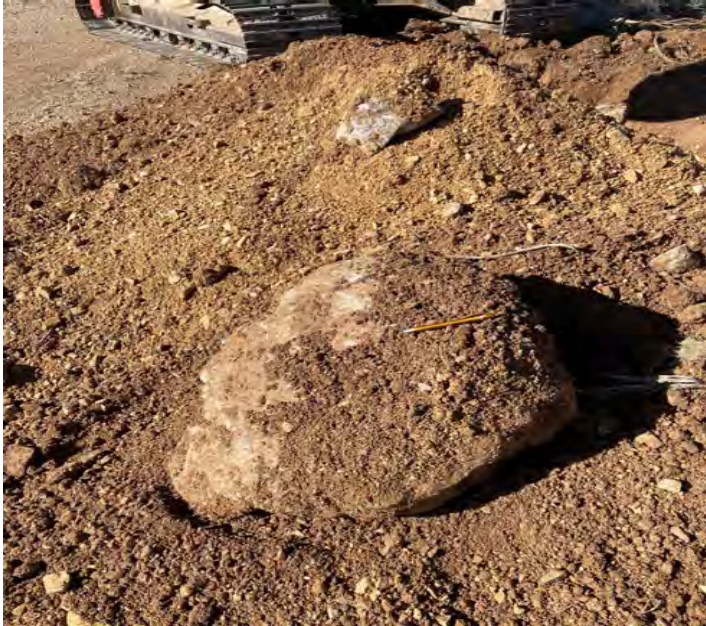
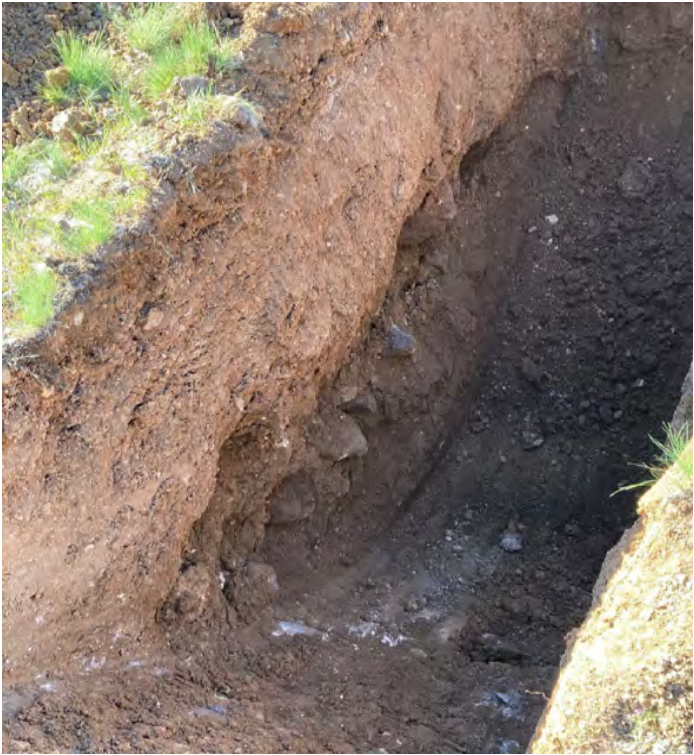
**Plate
B-40**

Test Pit 6 at 9' and Stockpile from Test Pit 6

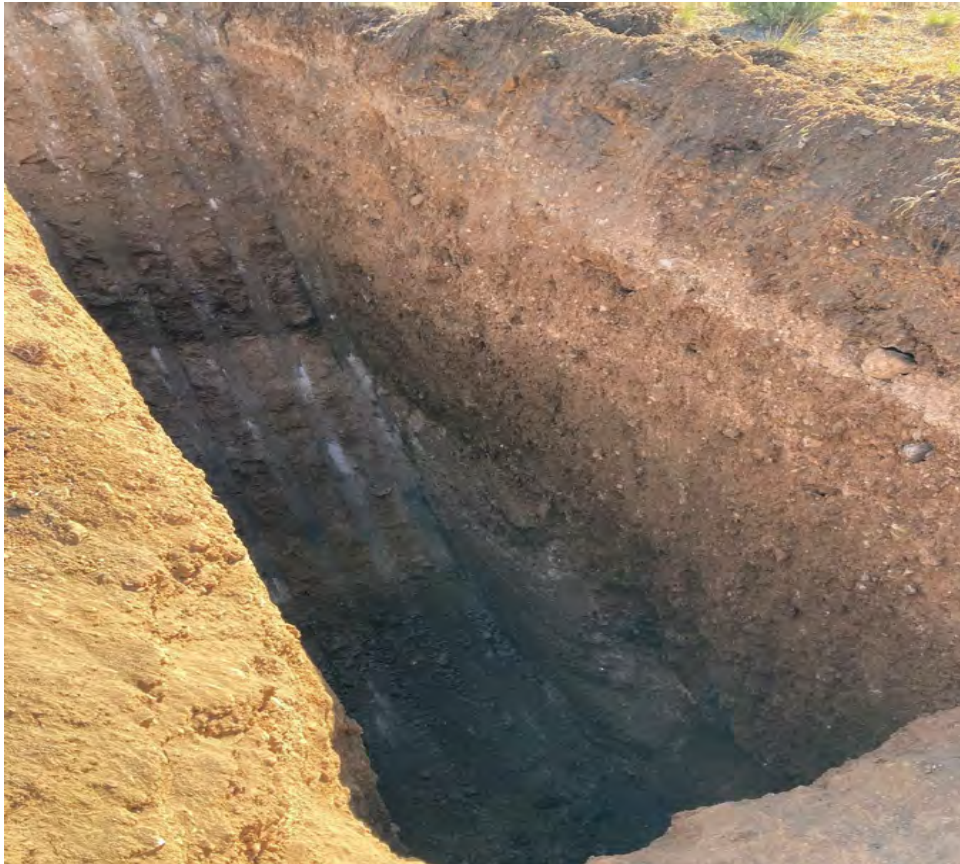
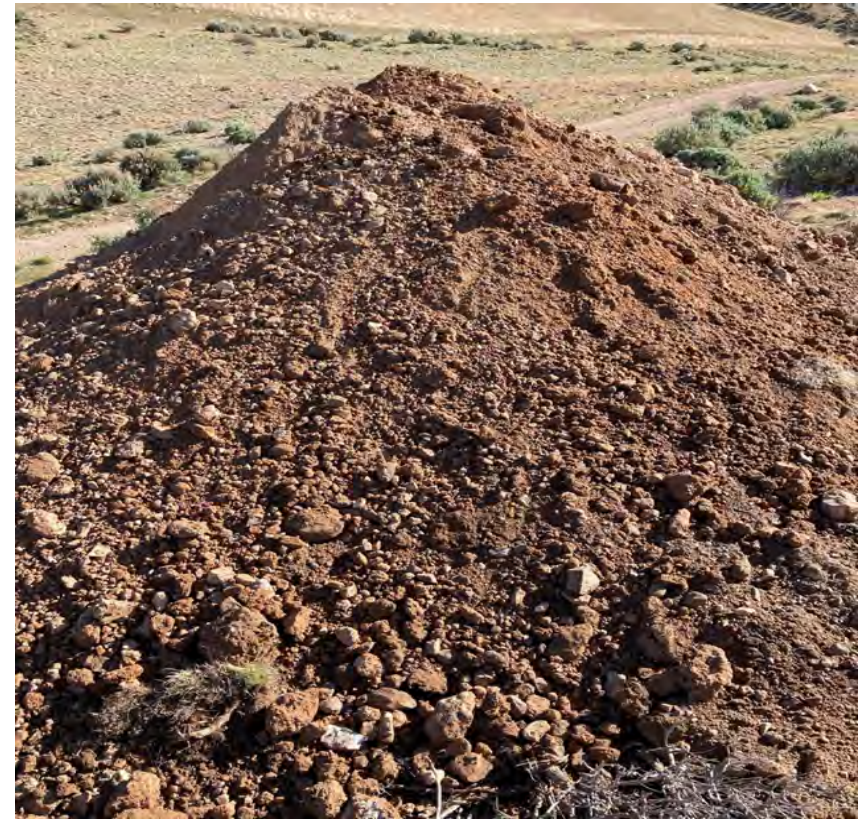
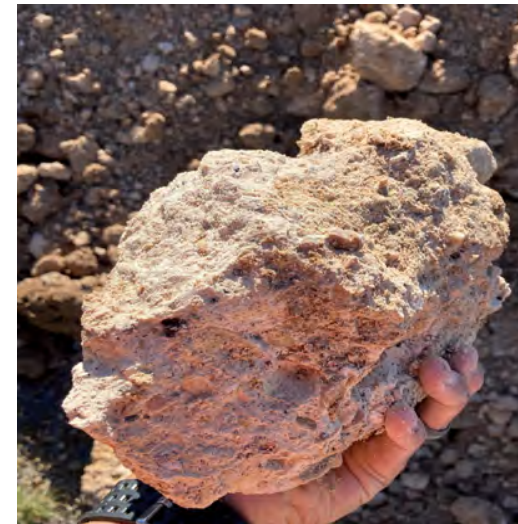
**Plate
B-41**

Test Pit 7 at 12' and Stockpile from Test Pit 7

Test pit DS-TP-07 is located east of D6 and at the mouth of Drainage 7 (D7). The soils encountered in this test pit were observed to be a Clayey Gravel (GC) with sand. Blocks of calcium carbonate cemented sand and rounded pea size gravel were encountered between 6 and 8 feet in depth (Plate B-41). Based on our field investigation, it is our opinion that the soils encountered in DS-TP-07 are alluvial fan flooding and Lake Bonneville deposits.
