Geotechnical Investigation

Micron Property – Lehi Emerald and Single Family

**Approximately 500 West and State Road 92
Lehi, Utah**

**Preliminary Geotechnical Investigation
Micron Property Lehi Single Family 145-Acre Portion
Approximately 500 West and State Road 92
Lehi, Utah**

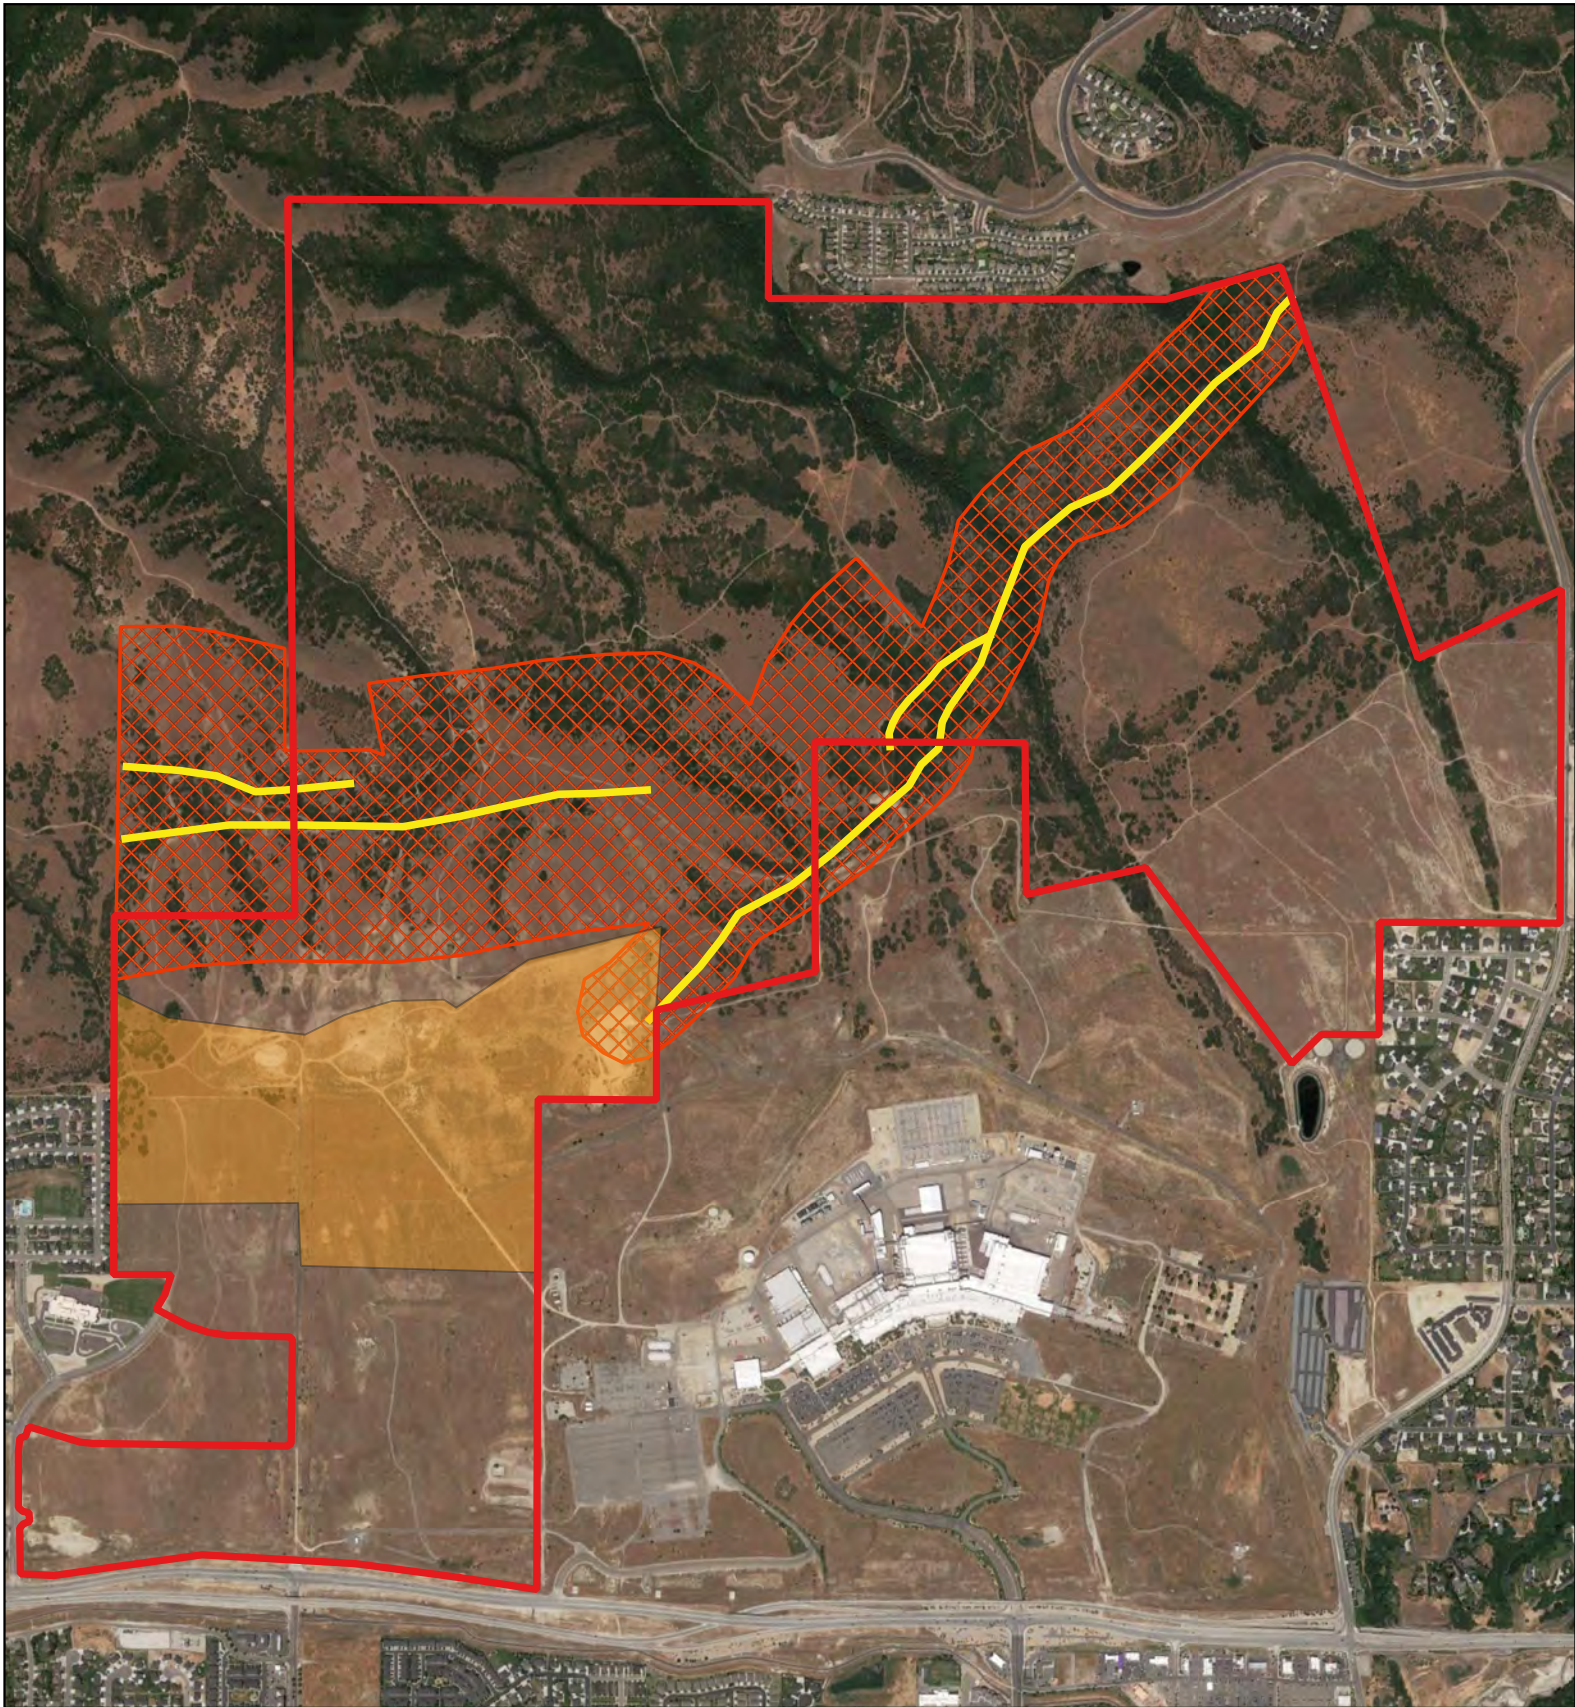
**Plate
 A-5**

D.R. Horton
 Mircon Property
 Lehi/Draper, Utah
 Project Number 589-100
Fault and Fault Special Study Area Map

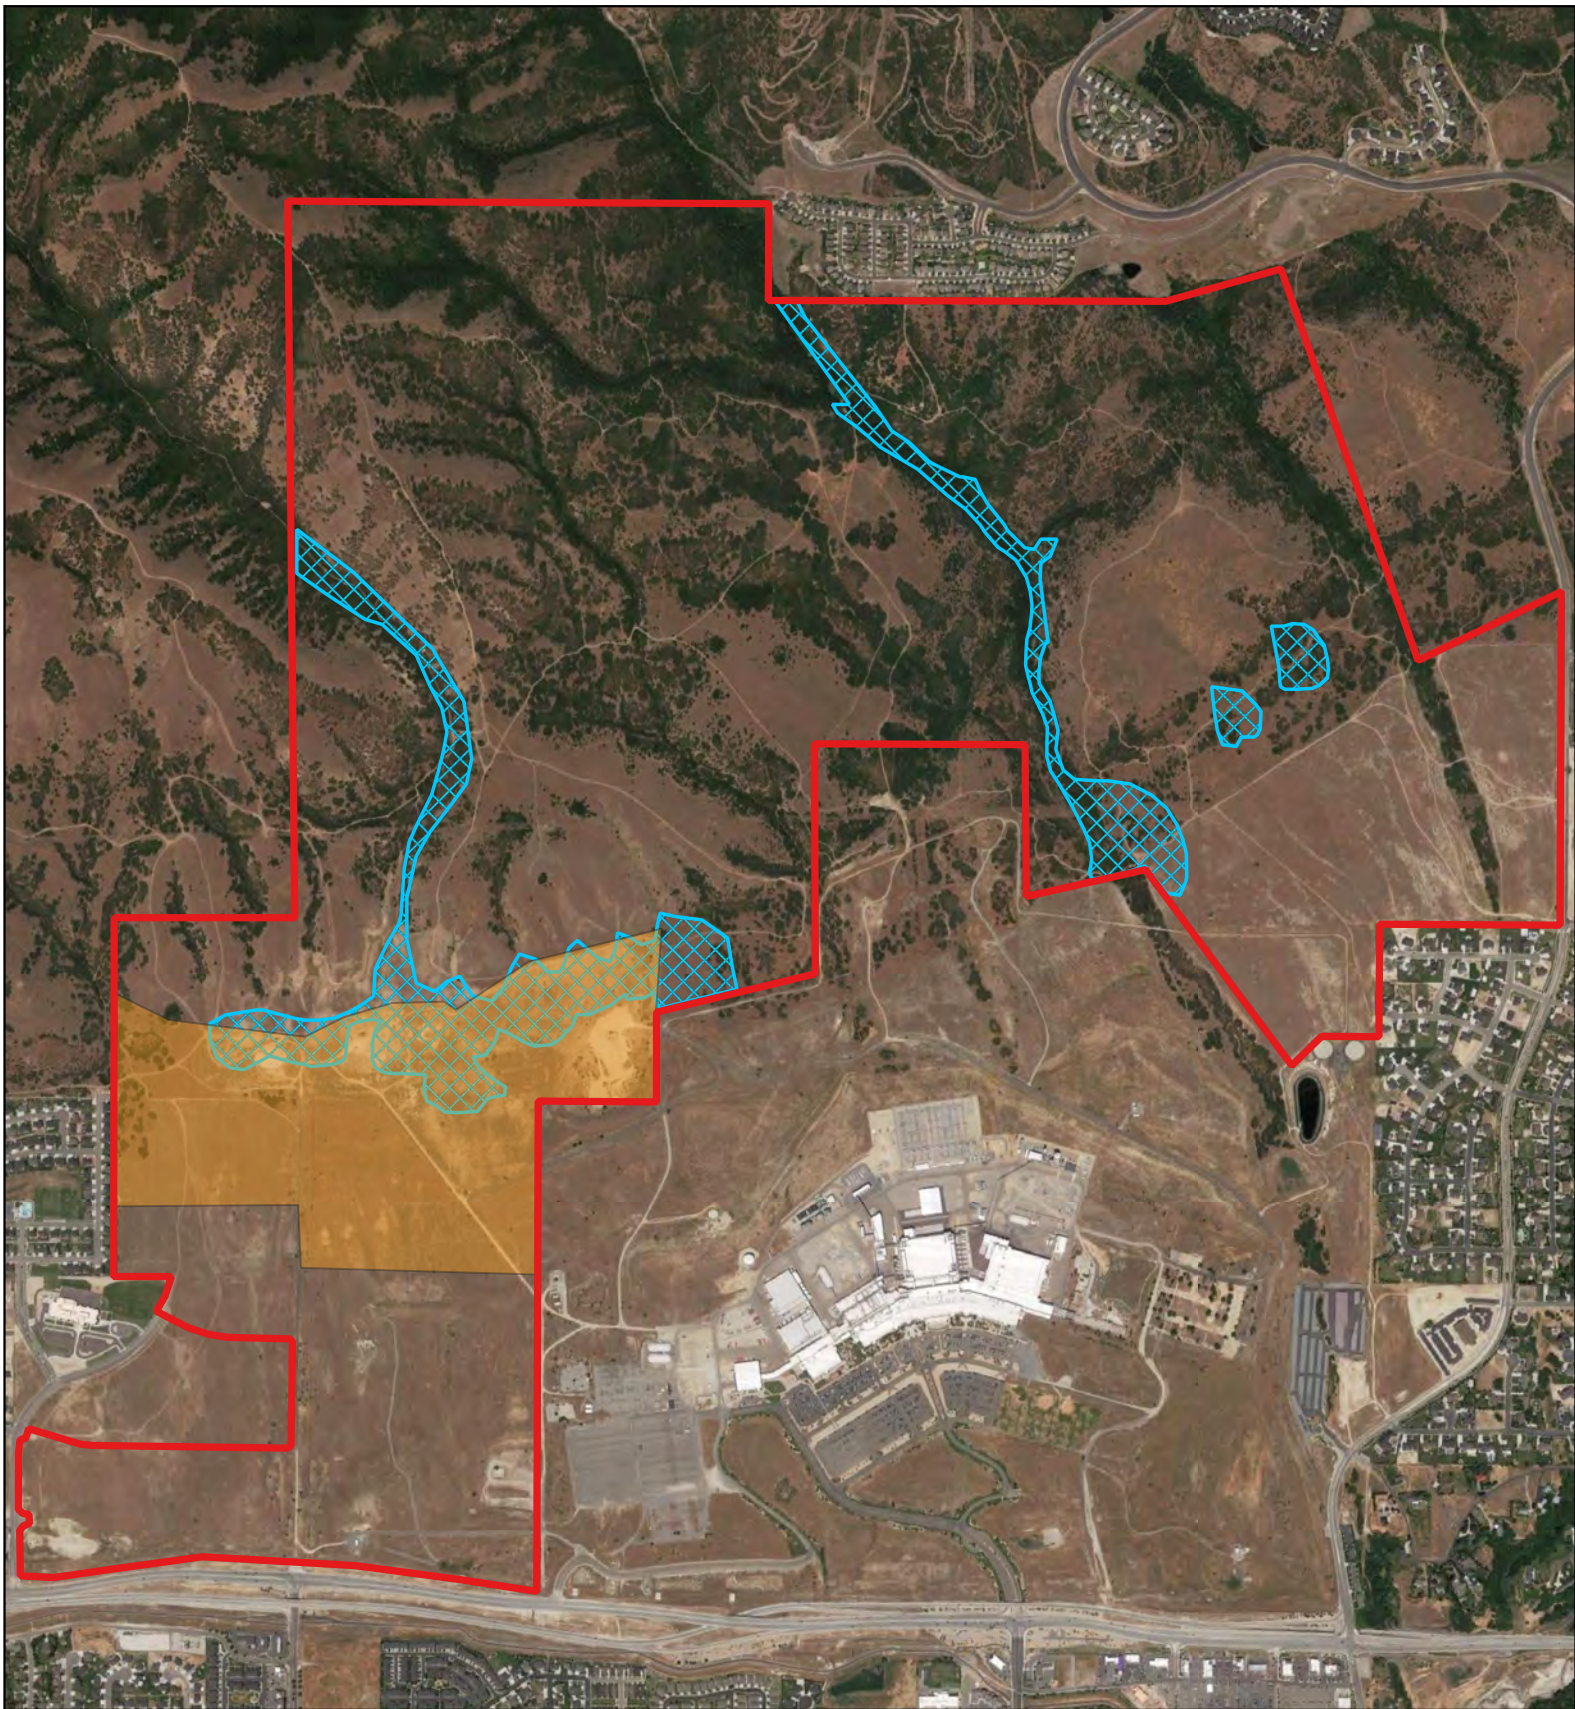
**Plate
 A-6**

D.R. Horton
 Mircon Property
 Lehi/Draper, Utah
 Project Number 589-100
Debris Flow Special Study Area Map

According to the latest update to the Geologic Hazards on Utah Geologic Hazard Portal, a portion of the 145-acre portion of Micron property is located in special study areas for debris flows and slope stability. Maps of these hazard are included on Plates A-6 to A-7. Recommendations for development in these mapped hazards special study areas, should be address in geologic hazard report or reports. The results of these reports and findings may limit the development, or require mitigation prior to the development of the site.

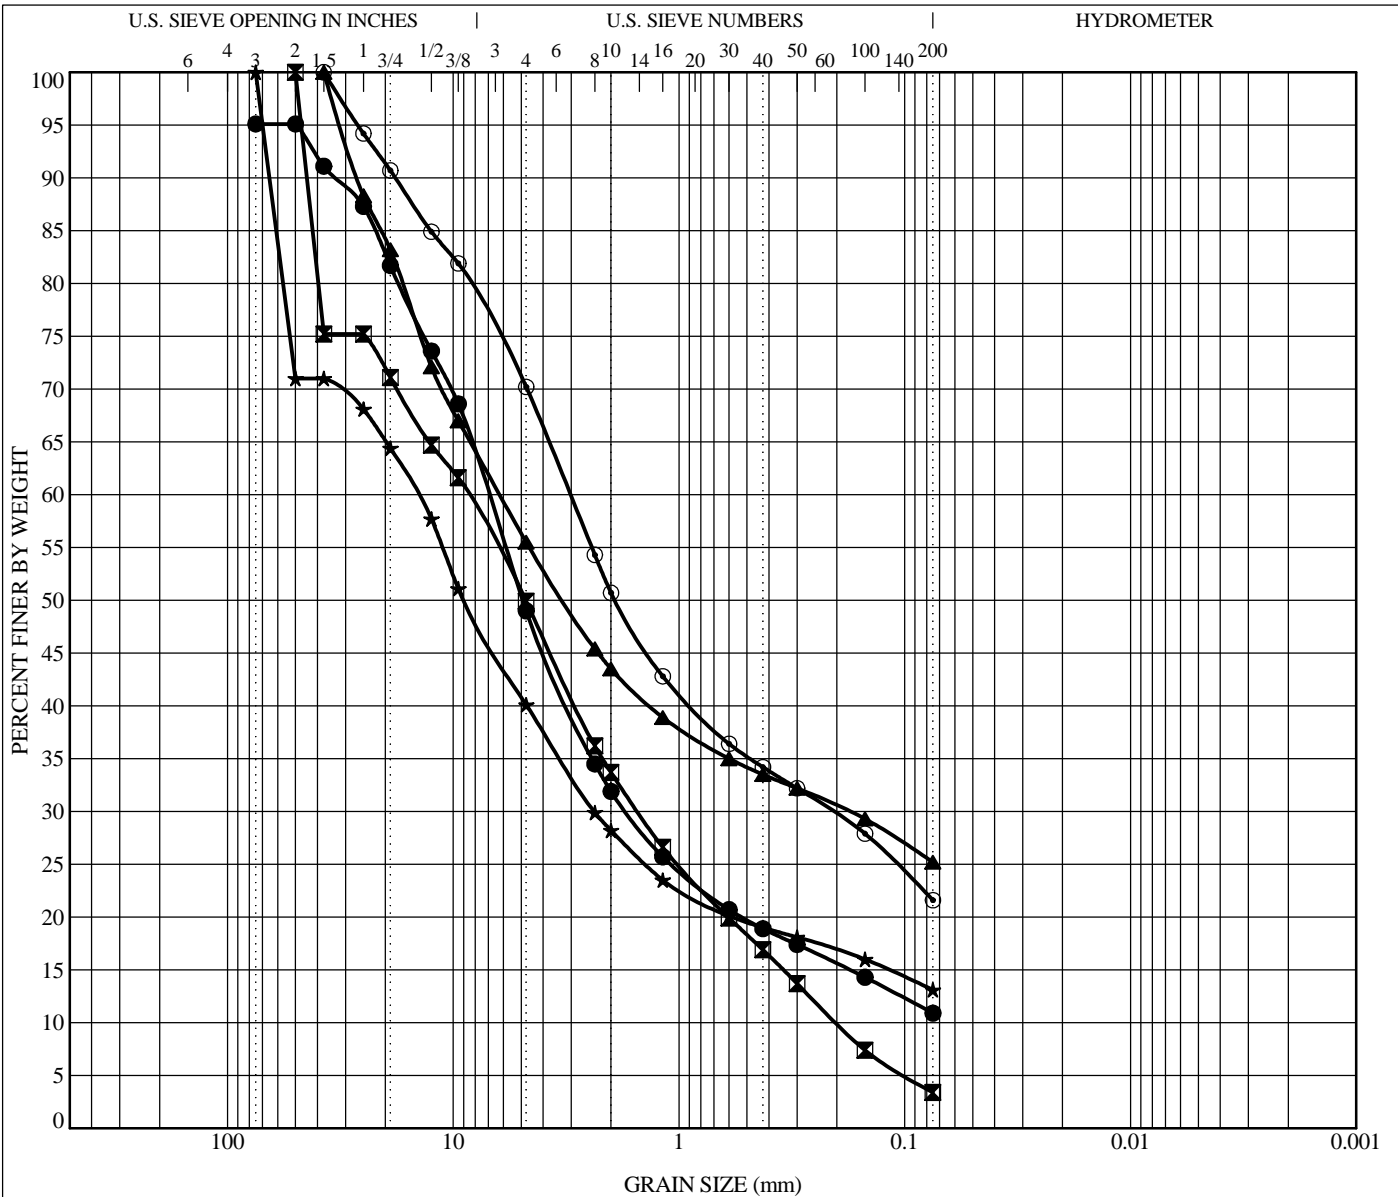
Plate
C - 4

Sample Location	Depth	Classification					LL	PL	PI	Cc	Cu
● MW-TP-01	7.0	Poorly Graded GRAVEL with silt and sand					22	18	4	6.62	112.27
☒ MW-TP-02	8.0	Poorly Graded GRAVEL with sand					NP	NP	NP	1.34	43.27
▲ MW-TP-04	3.0	Clayey GRAVEL with sand					24	16	8		
★ MW-TP-10	2.0	Poorly Graded GRAVEL with clay and sand					25	16	9		
◎ MW-TP-11	6.0	Silty SAND with gravel					NP	NP	NP		
Sample Location	Depth	D100	D60	D30	D10	%Gravel	%Sand	%Silt	%Clay		
● MW-TP-01	7.0	75	7.009	1.701		46.1	38.1	10.9			
☒ MW-TP-02	8.0	50	8.641	1.519	0.2	50.1	46.5	3.4			
▲ MW-TP-04	3.0	37.5	6.23	0.177		44.5	30.3	25.2			
★ MW-TP-10	2.0	75	14.432	2.376		59.9	27.0	13.1			
◎ MW-TP-11	6.0	37.5	3.033	0.21		29.8	48.6	21.6

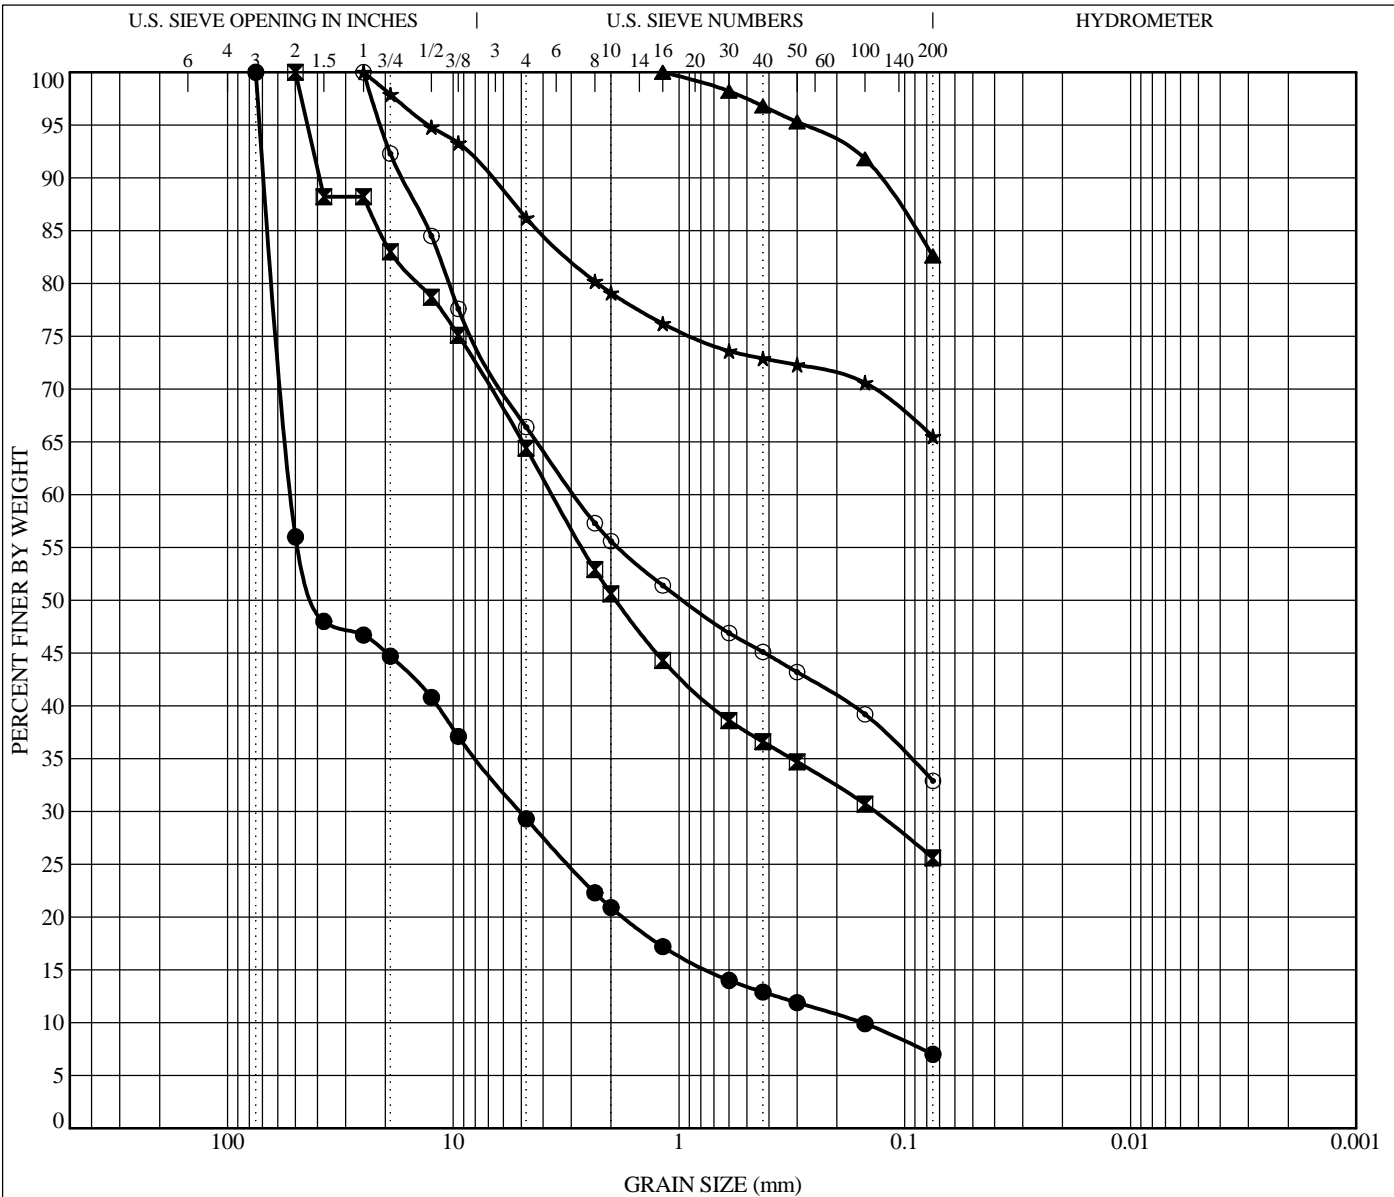
Plate
C - 5

Sample Location	Depth	Classification					LL	PL	PI	Cc	Cu
● MW-TP-16	1.5	Poorly Graded GRAVEL with silt and sand					NP	NP	NP	3.17	334.07
■ MW-TP-17	4.0	Silty SAND with gravel					NP	NP	NP		
▲ MW-TP-21	3.5	Lean CLAY with sand					38	24	14		
★ MW-TP-22	2.0	Sandy Lean CLAY					29	16	13		
⊙ MW-TP-23	1.5	Clayey GRAVEL with sand					24	17	7		
Sample Location	Depth	D100	D60	D30	D10	%Gravel	%Sand	%Silt	%Clay		
● MW-TP-16	1.5	75	51.877	5.055	0.155	70.7	22.3	7.0			
■ MW-TP-17	4.0	50	3.635	0.136		35.6	38.8	25.6			
▲ MW-TP-21	3.5	1.18				0.0	17.4	82.6			
★ MW-TP-22	2.0	25				13.8	20.7	65.5			
⊙ MW-TP-23	1.5	25	2.904			33.6	33.5	32.9

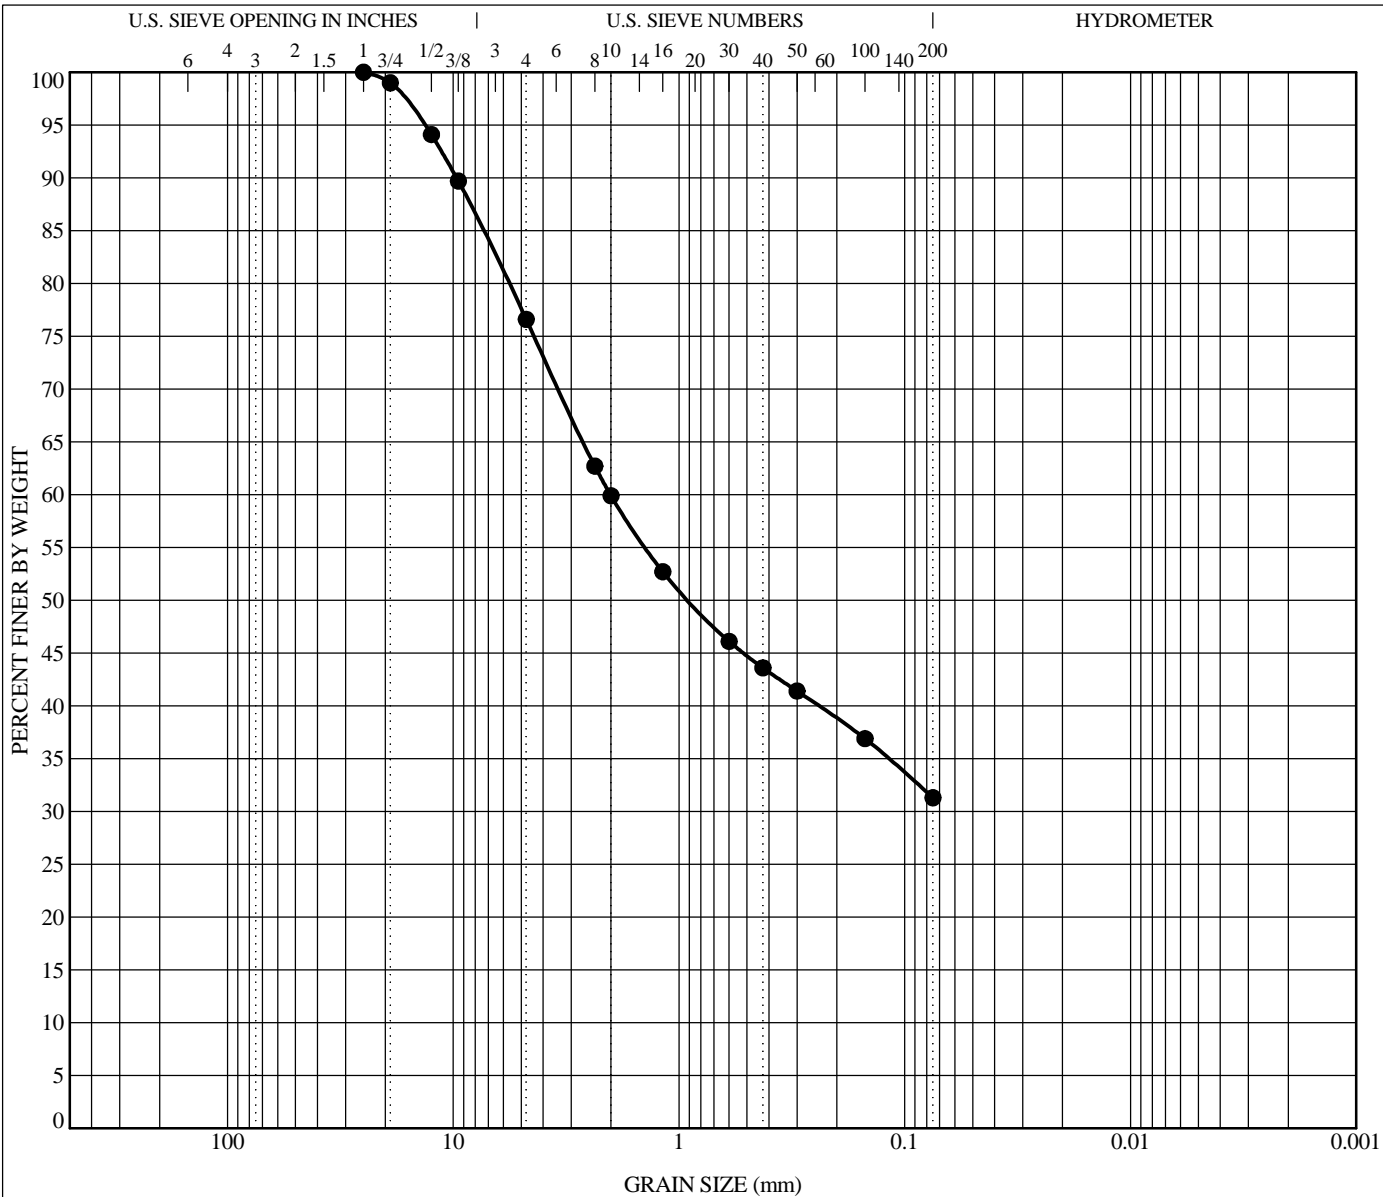
Plate
C - 6

Sample Location	Depth	Classification					LL	PL	PI	Cc	Cu
● MW-TP-29	2.0	Clayey SAND with gravel					30	15	15

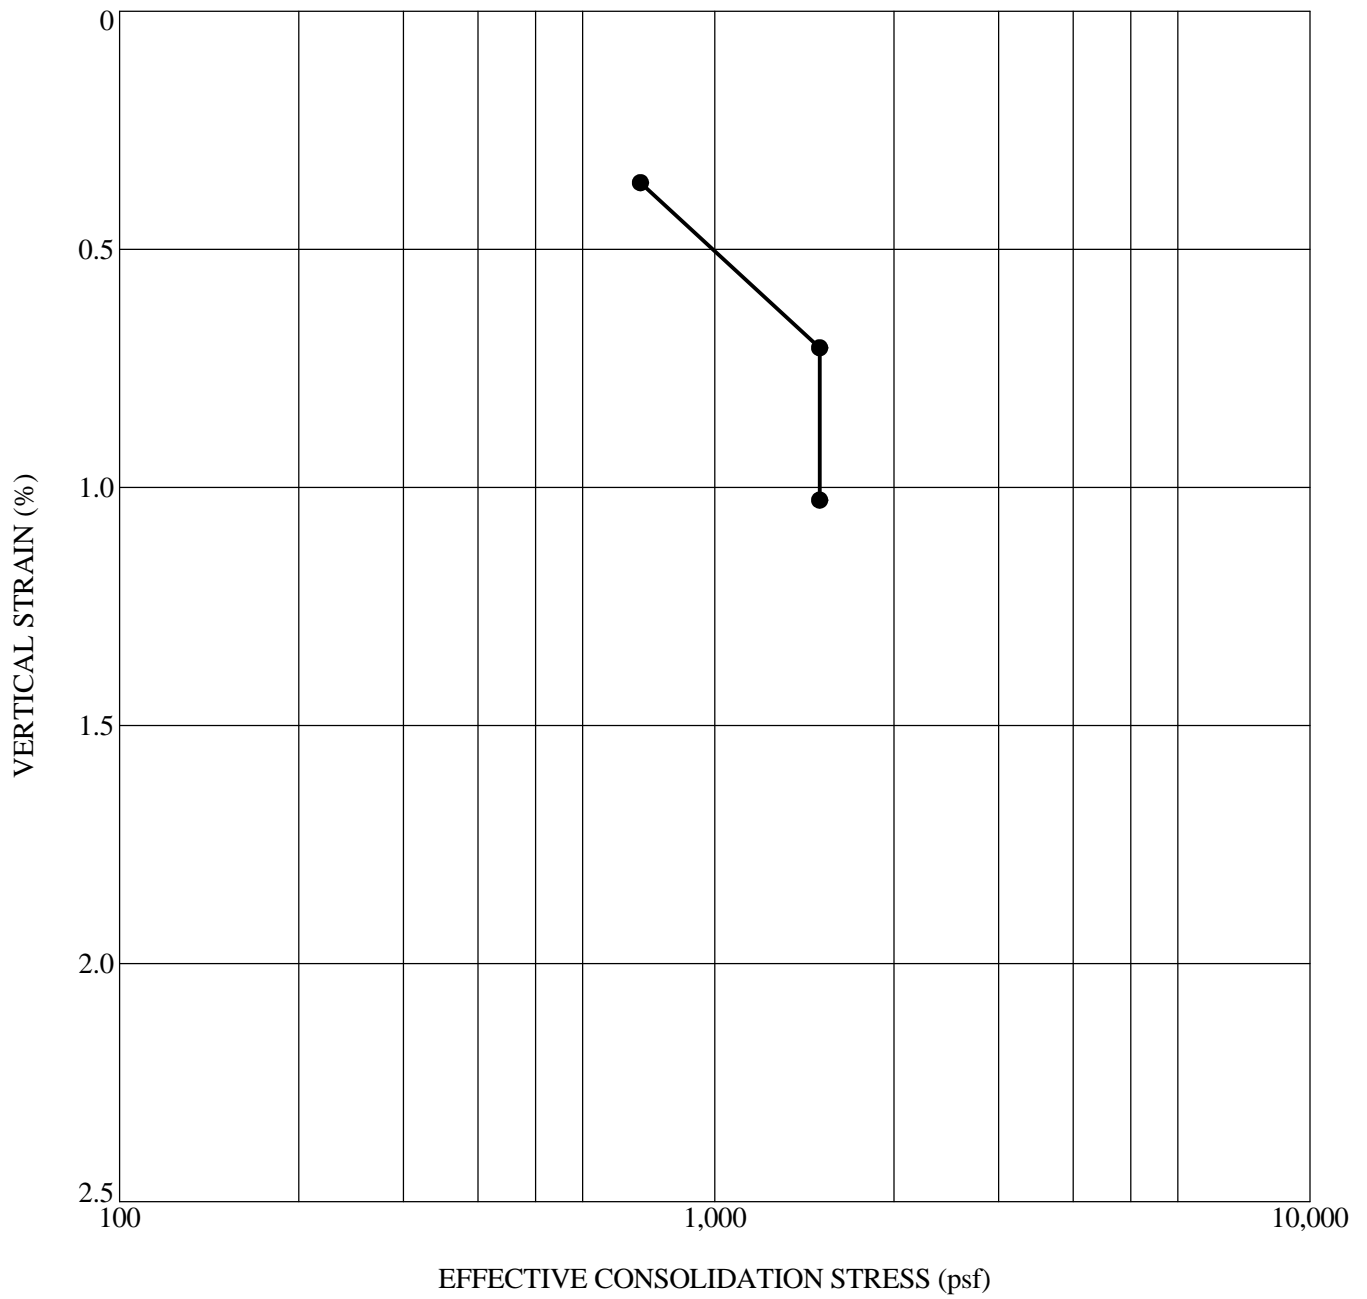
Plate
C - 7

Sample Location	Depth (ft)	Classification	γ_a (pcf)	MC (%)	C'_c	C'_r	OCR	Inundation Load (psf)	Swell (%)	Collapse (%)
● MW-TP-03	3.0		93	9				1500		0.32

Soils that have a potential to collapse under increased loading and moisture conditions are typically characterized by a pinhole structure and relatively low unit weights. In general, potentially collapsible soils are observed in fine-grained soils that include clay and silt, although collapsible soils may include sandy soils. Test results of the collapse test show negligible to low collapse potential. A table of the collapse test results, depth, and test pit number are provided below. This information is also contained on Plate C-1 and Plates C-7 to C-16.

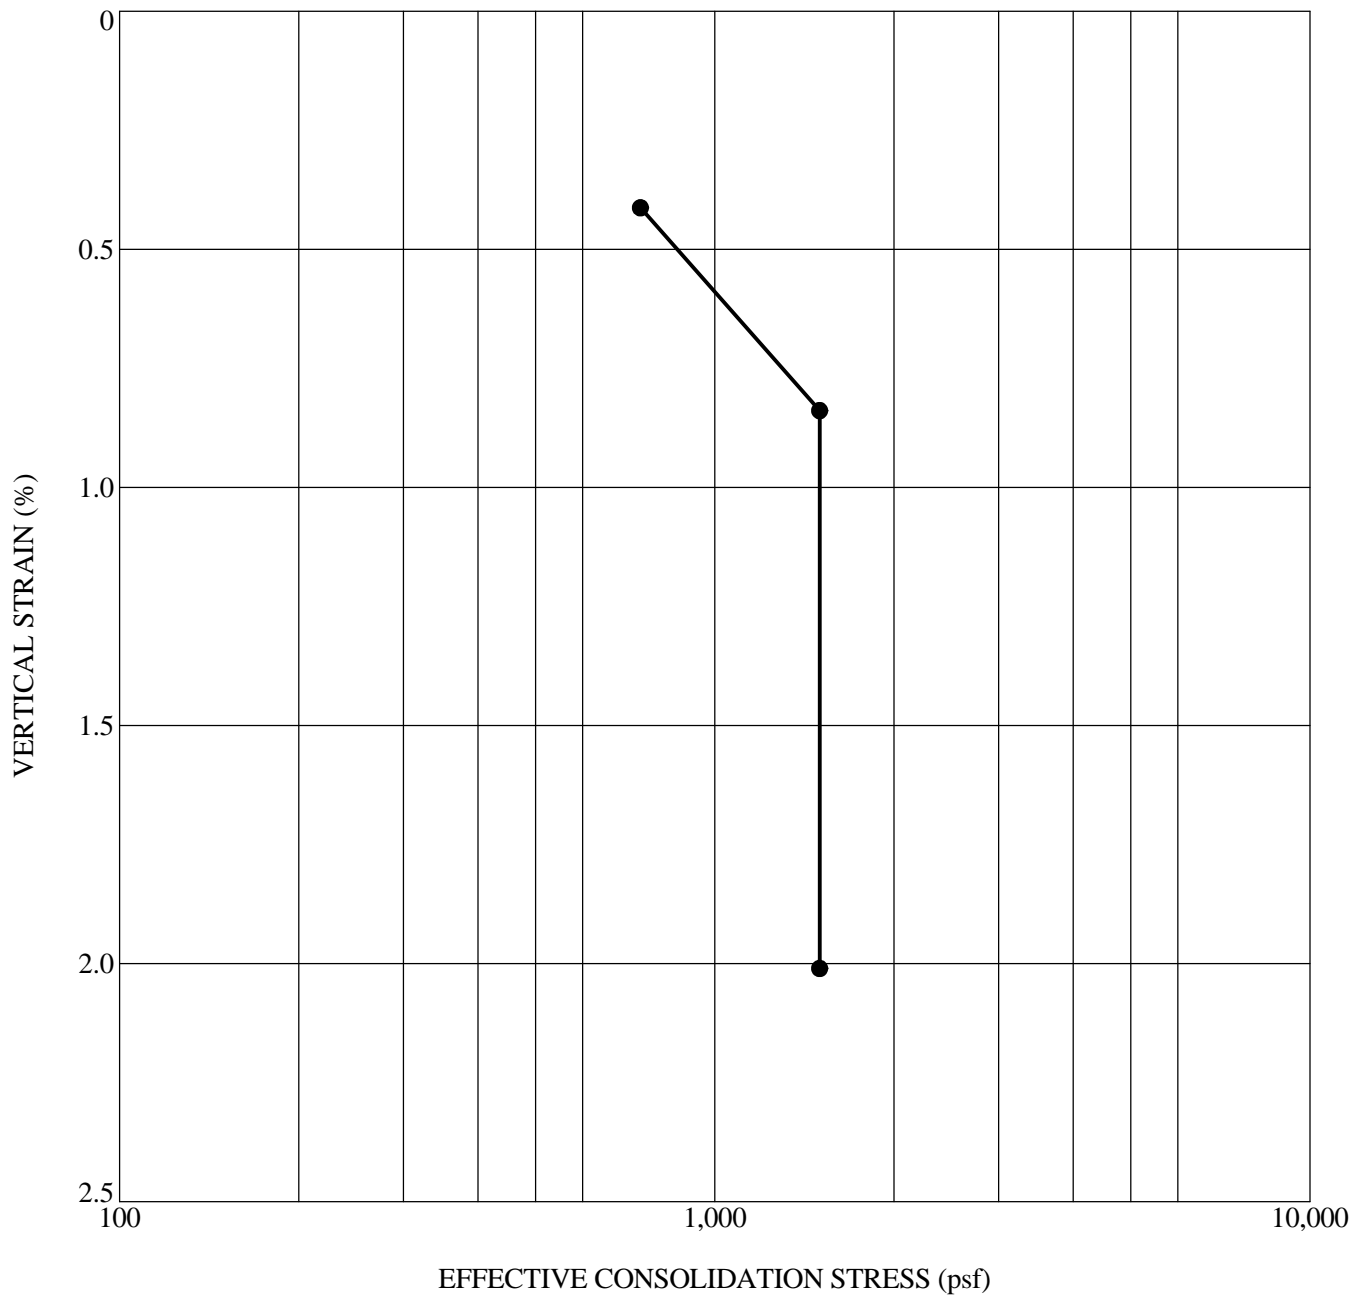
Plate
C - 8

Sample Location	Depth (ft)	Classification	γ_a (pcf)	MC (%)	C'_c	C'_r	OCR	Inundation Load (psf)	Swell (%)	Collapse (%)
● MW-TP-12	6.0	Silty SAND	95	7				1500		1.17

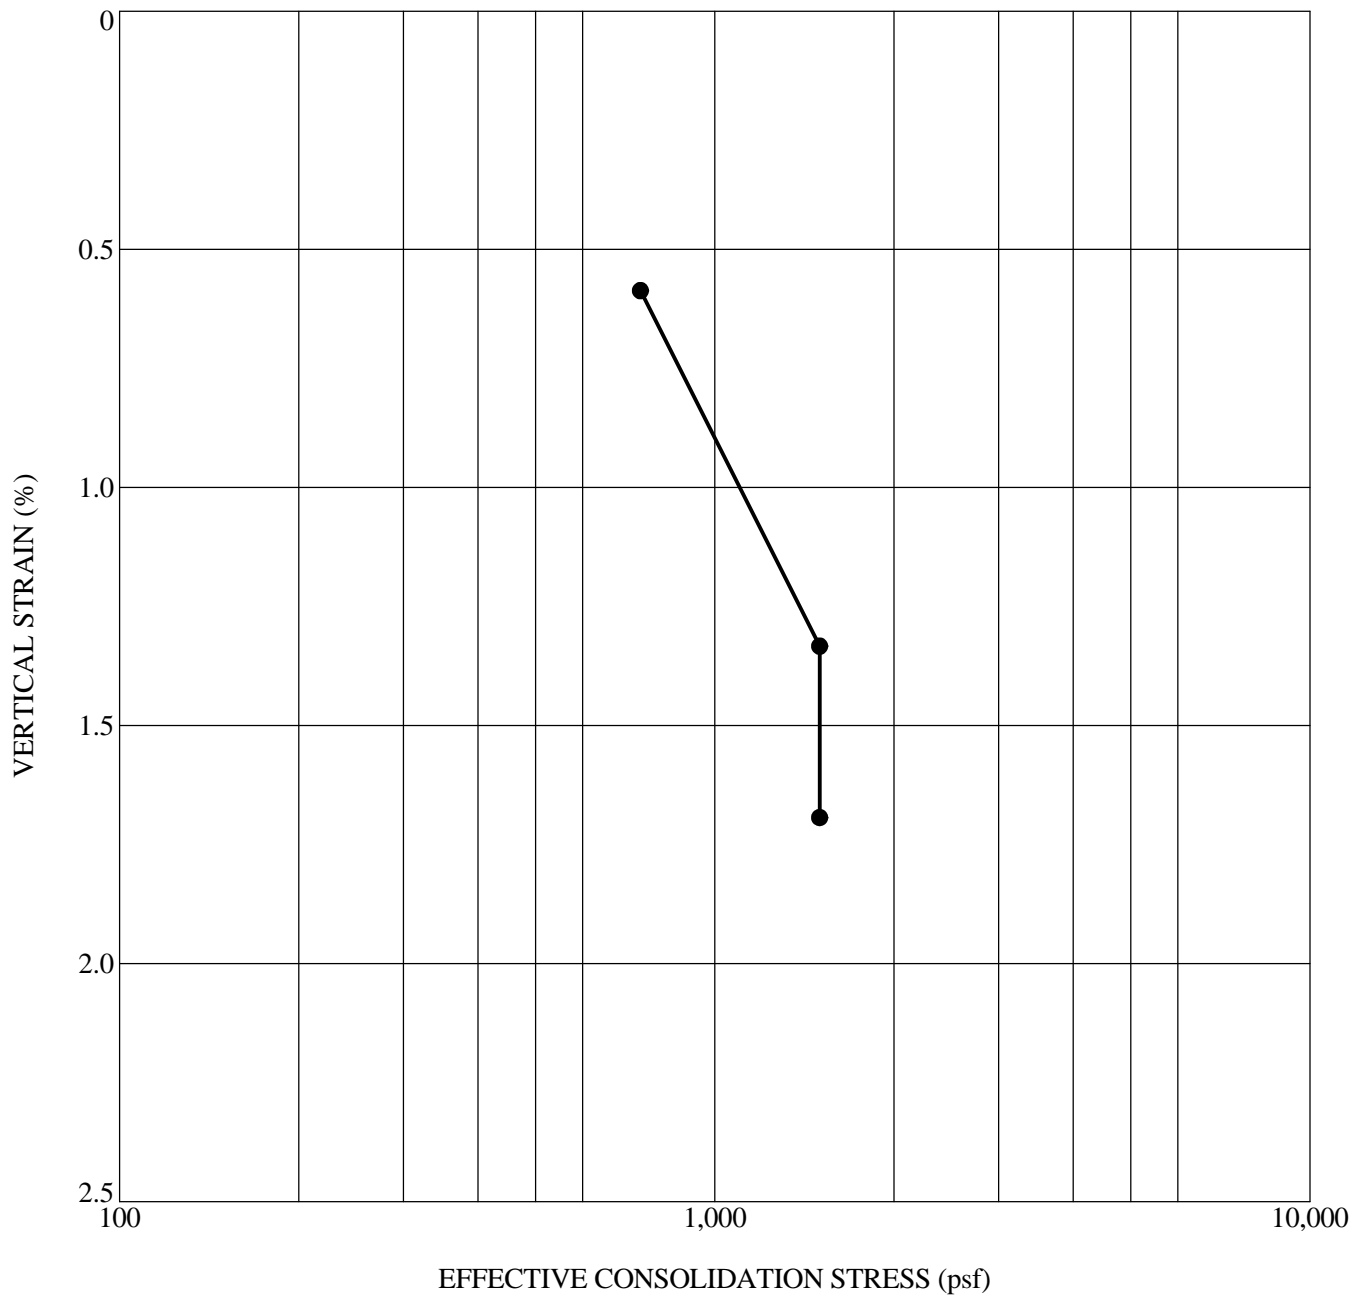
Plate
C - 9

Sample Location	Depth (ft)	Classification	γ_a (pcf)	MC (%)	C'_c	C'_r	OCR	Inundation Load (psf)	Swell (%)	Collapse (%)
● MW-TP-13	8.5	Silty SAND	81	17				1500		0.27

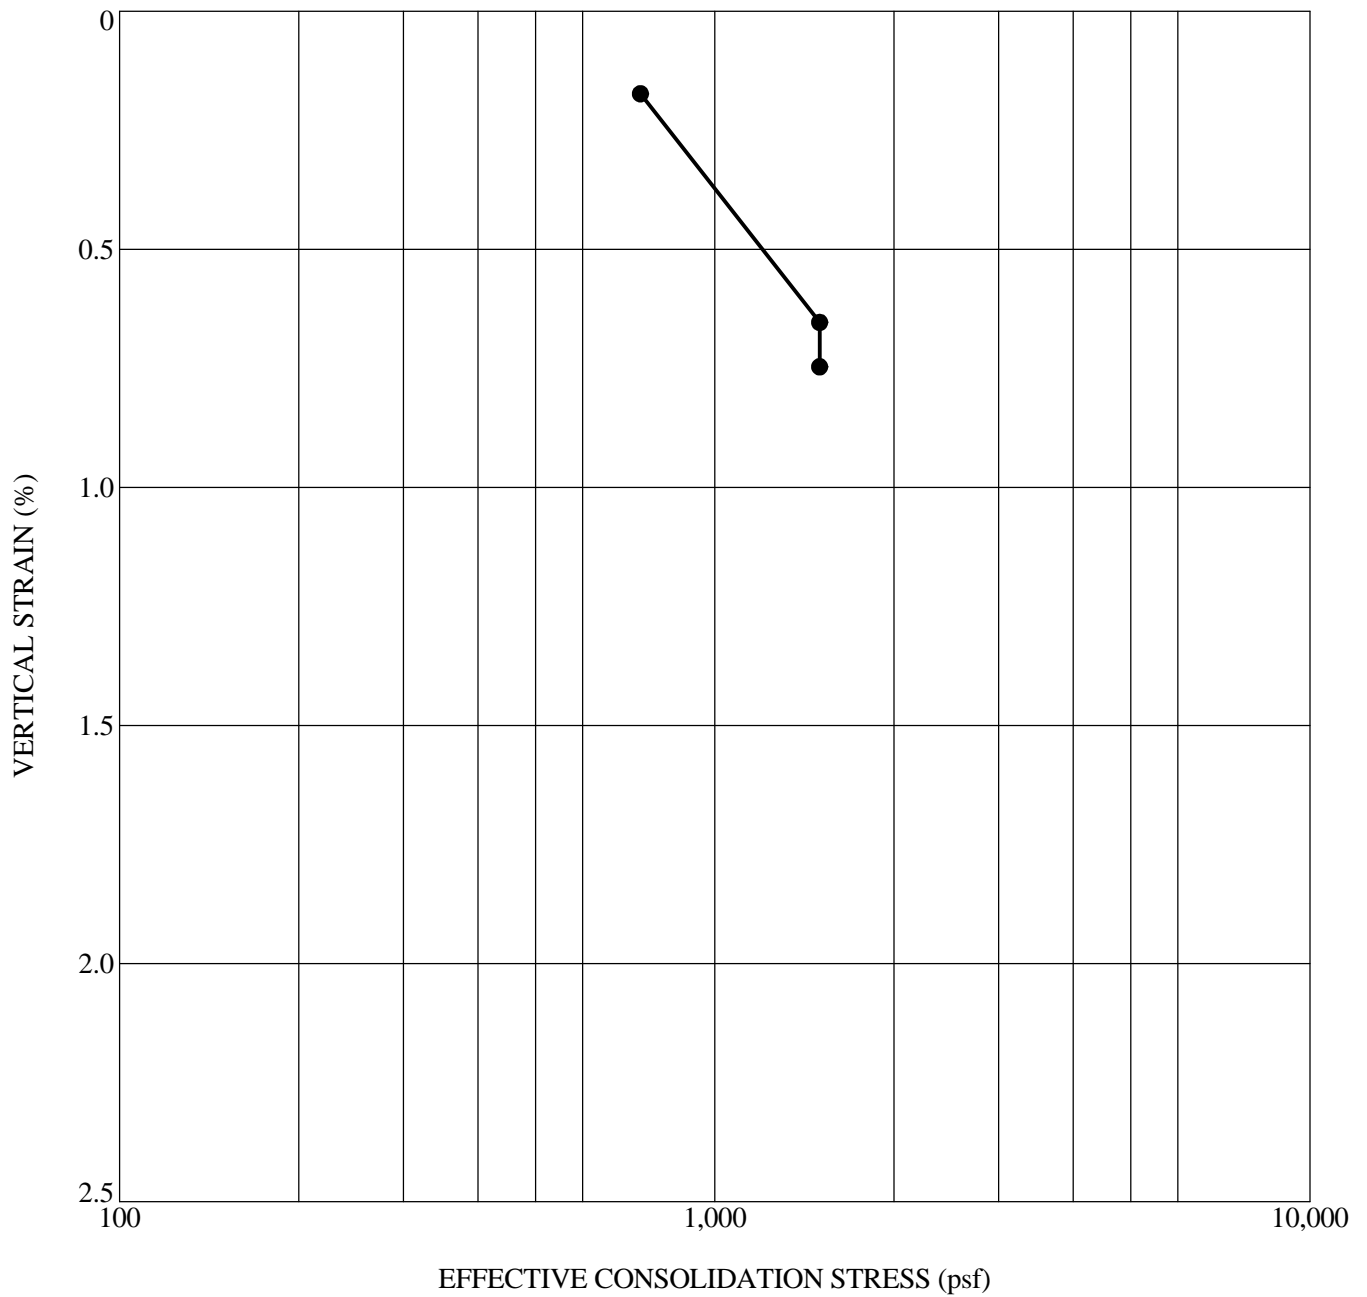
Plate
C - 10

Sample Location	Depth (ft)	Classification	γ_a (pcf)	MC (%)	C'_c	C'_r	OCR	Inundation Load (psf)	Swell (%)	Collapse (%)
● MW-TP-14	6.0	Silty SAND with gravel	98	14				1500		0.09

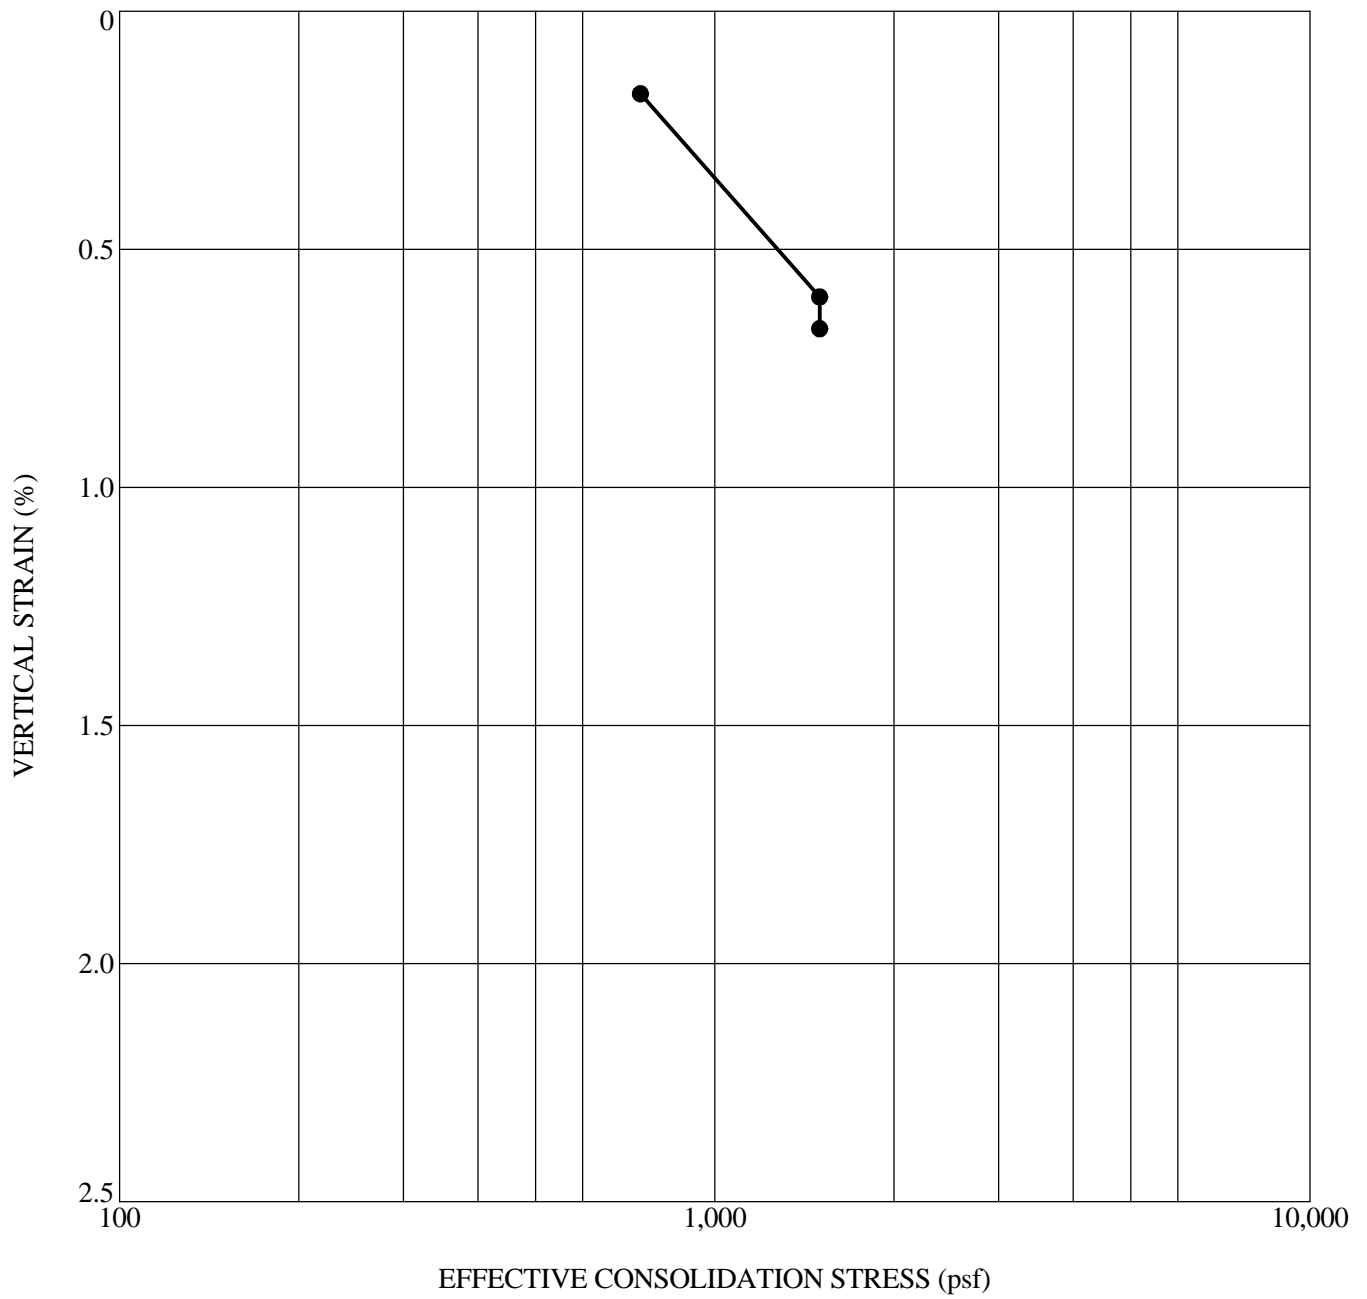
Plate
C - 11

Sample Location	Depth (ft)	Classification	γ_a (pcf)	MC (%)	C'_c	C'_r	OCR	Inundation Load (psf)	Swell (%)	Collapse (%)
● MW-TP-18	3.0	Lean CLAY with sand	87	20				1500		0.07

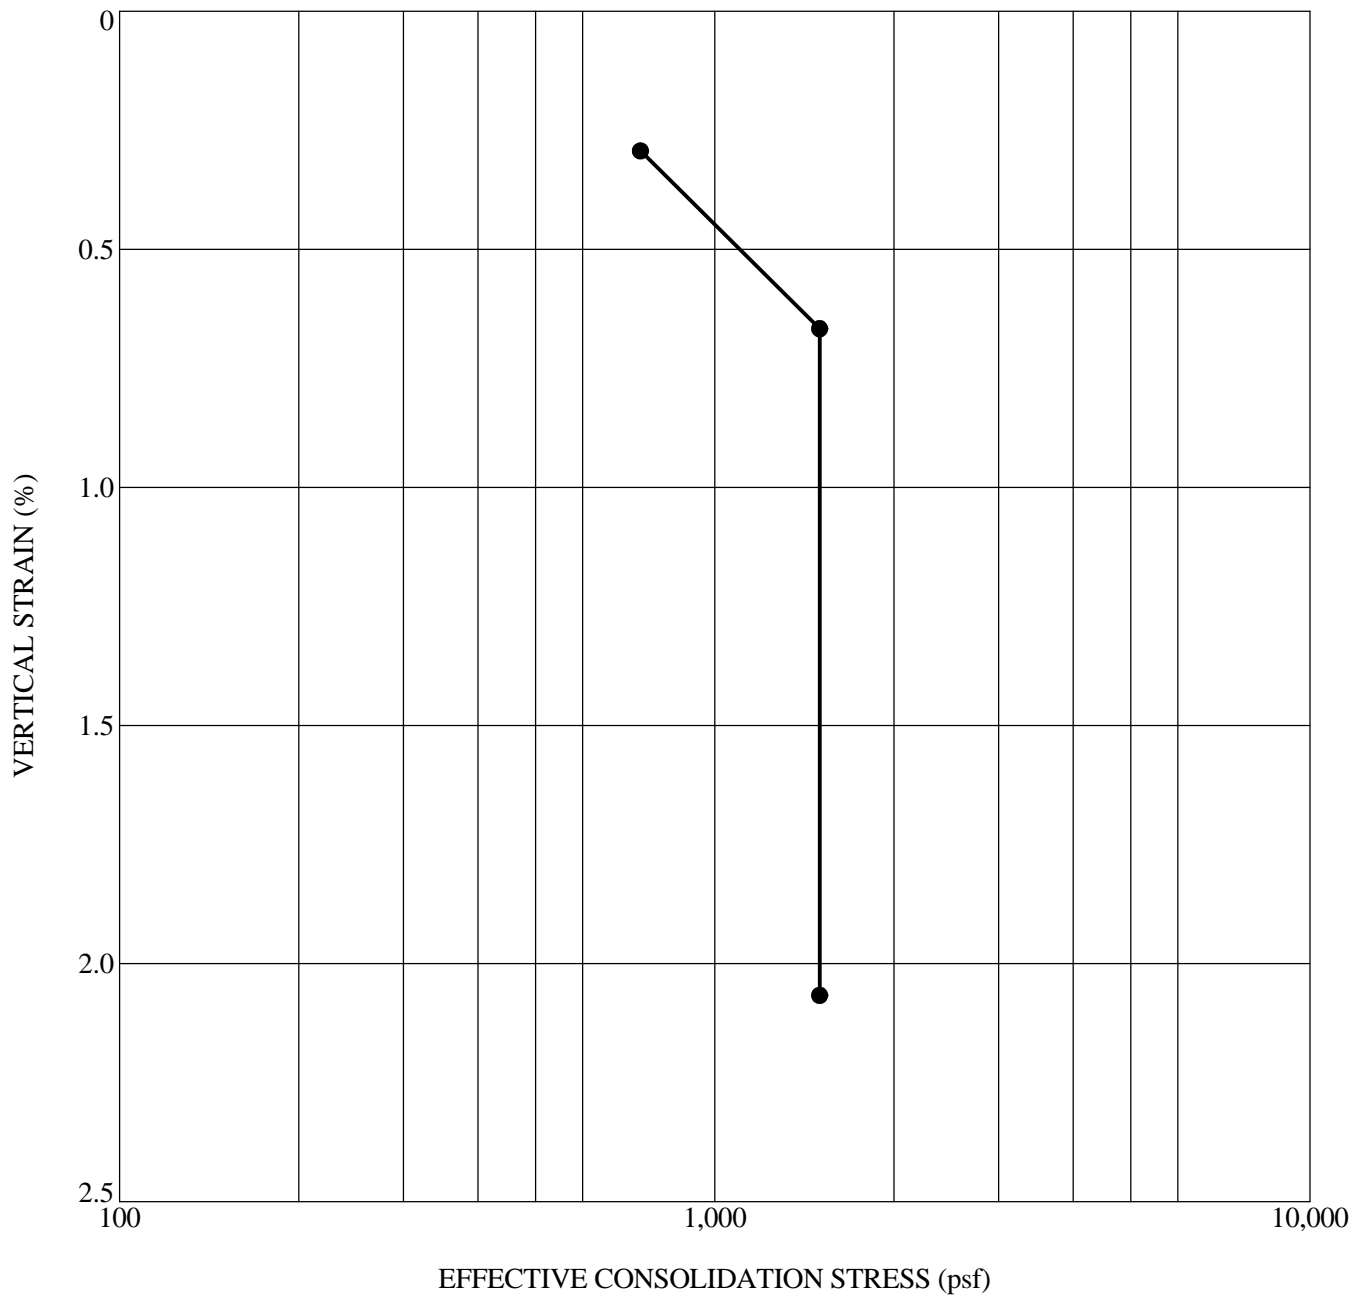
Plate
C - 12

Sample Location	Depth (ft)	Classification	γ_a (pcf)	MC (%)	C'_c	C'_r	OCR	Inundation Load (psf)	Swell (%)	Collapse (%)
● MW-TP-19	6.0	Sandy SILT	89	8				1500		1.40
