Geotechnical Investigation

Micron Property – Lehi Emerald and Single Family

**Approximately 500 West and State Road 92
Lehi, Utah**

**Preliminary Geotechnical Investigation
Micron Property Lehi Single Family 145-Acre Portion
Approximately 500 West and State Road 92
Lehi, Utah**

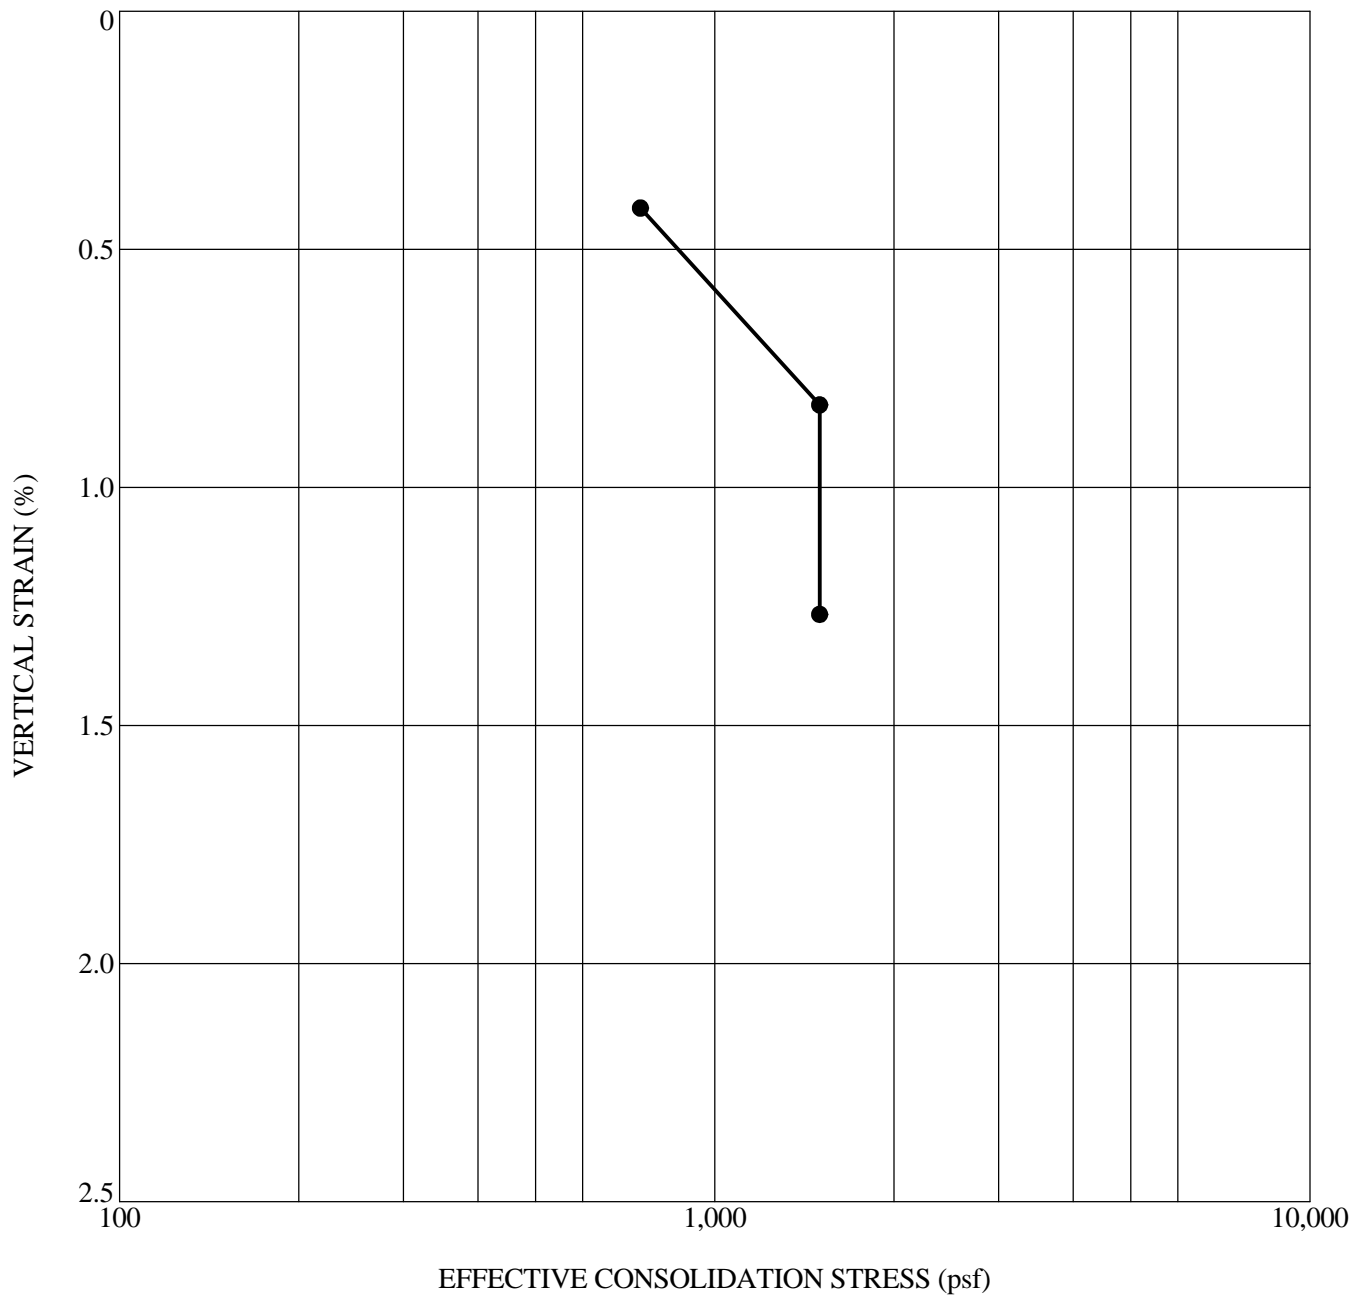
Plate
C - 13

Sample Location	Depth (ft)	Classification	γ_d (pcf)	MC (%)	C'_c	C'_r	OCR	Inundation Load (psf)	Swell (%)	Collapse (%)
● MW-TP-20	3.5		93	22				1500		0.44

Soils that have a potential to collapse under increased loading and moisture conditions are typically characterized by a pinhole structure and relatively low unit weights. In general, potentially collapsible soils are observed in fine-grained soils that include clay and silt, although collapsible soils may include sandy soils. Test results of the collapse test show negligible to low collapse potential. A table of the collapse test results, depth, and test pit number are provided below. This information is also contained on Plate C-1 and Plates C-7 to C-16.

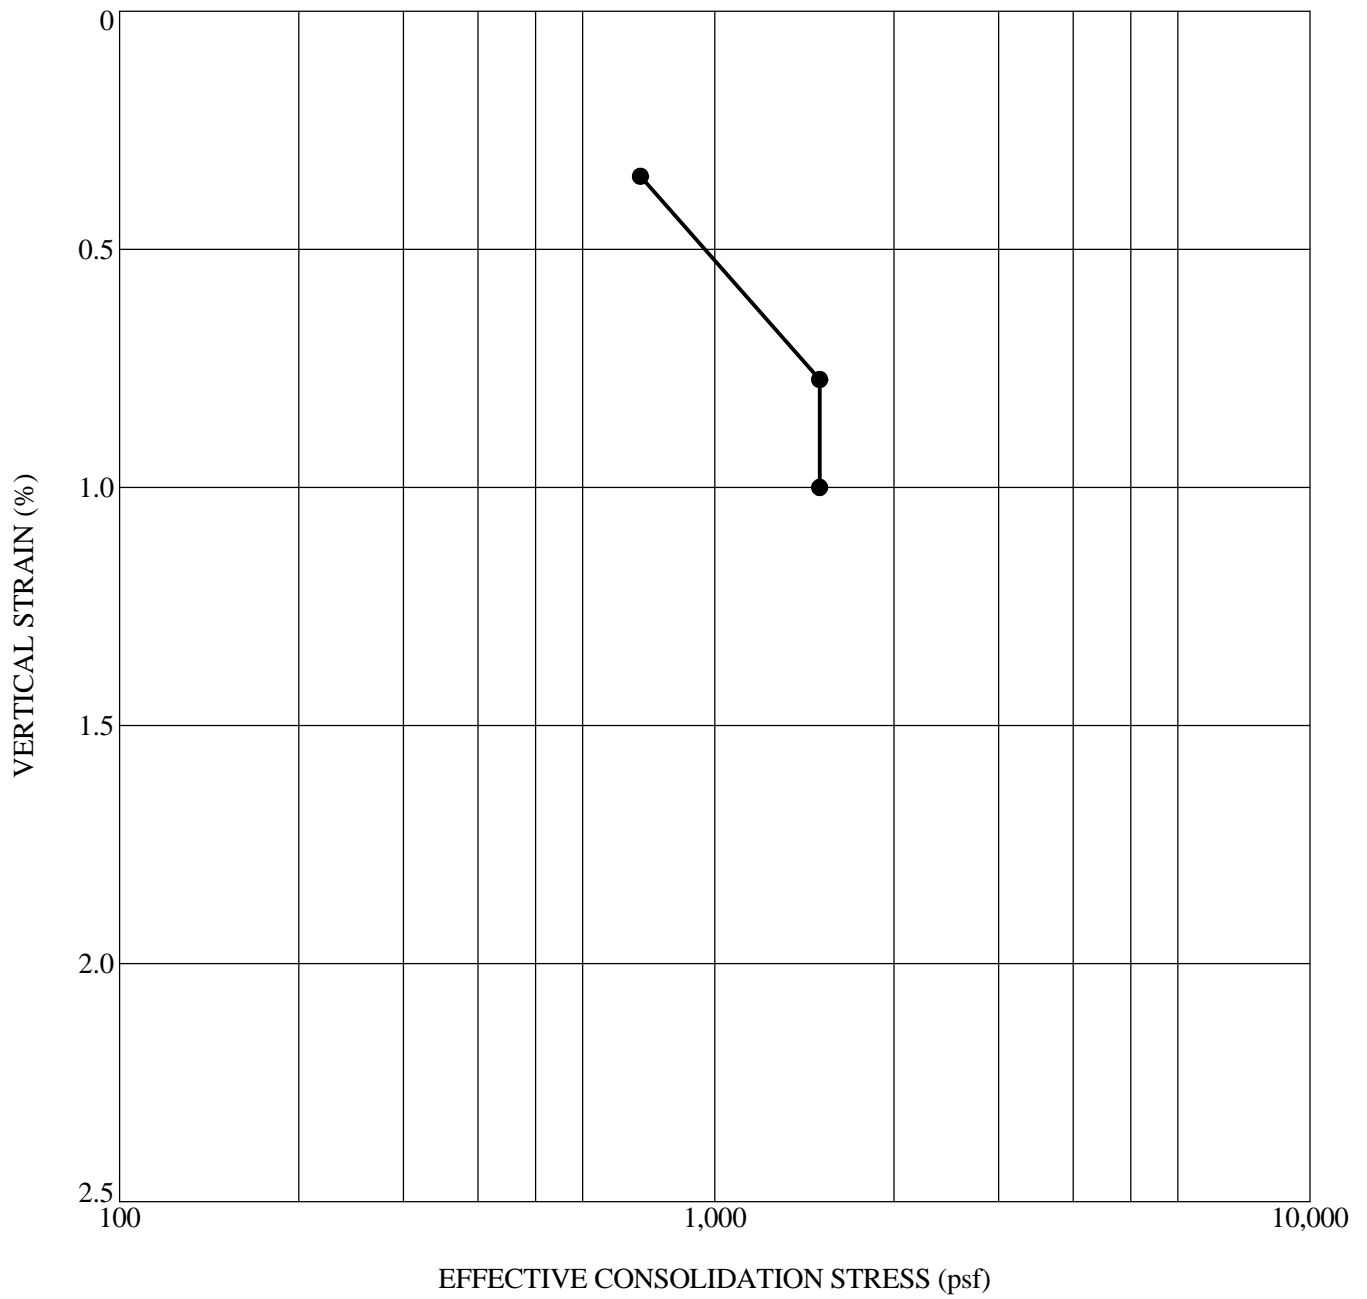
Plate
C - 14

Sample Location	Depth (ft)	Classification	γ_a (pcf)	MC (%)	C'_c	C'_r	OCR	Inundation Load (psf)	Swell (%)	Collapse (%)
● MW-TP-21	3.5	Lean CLAY with sand	87	16				1500		0.23

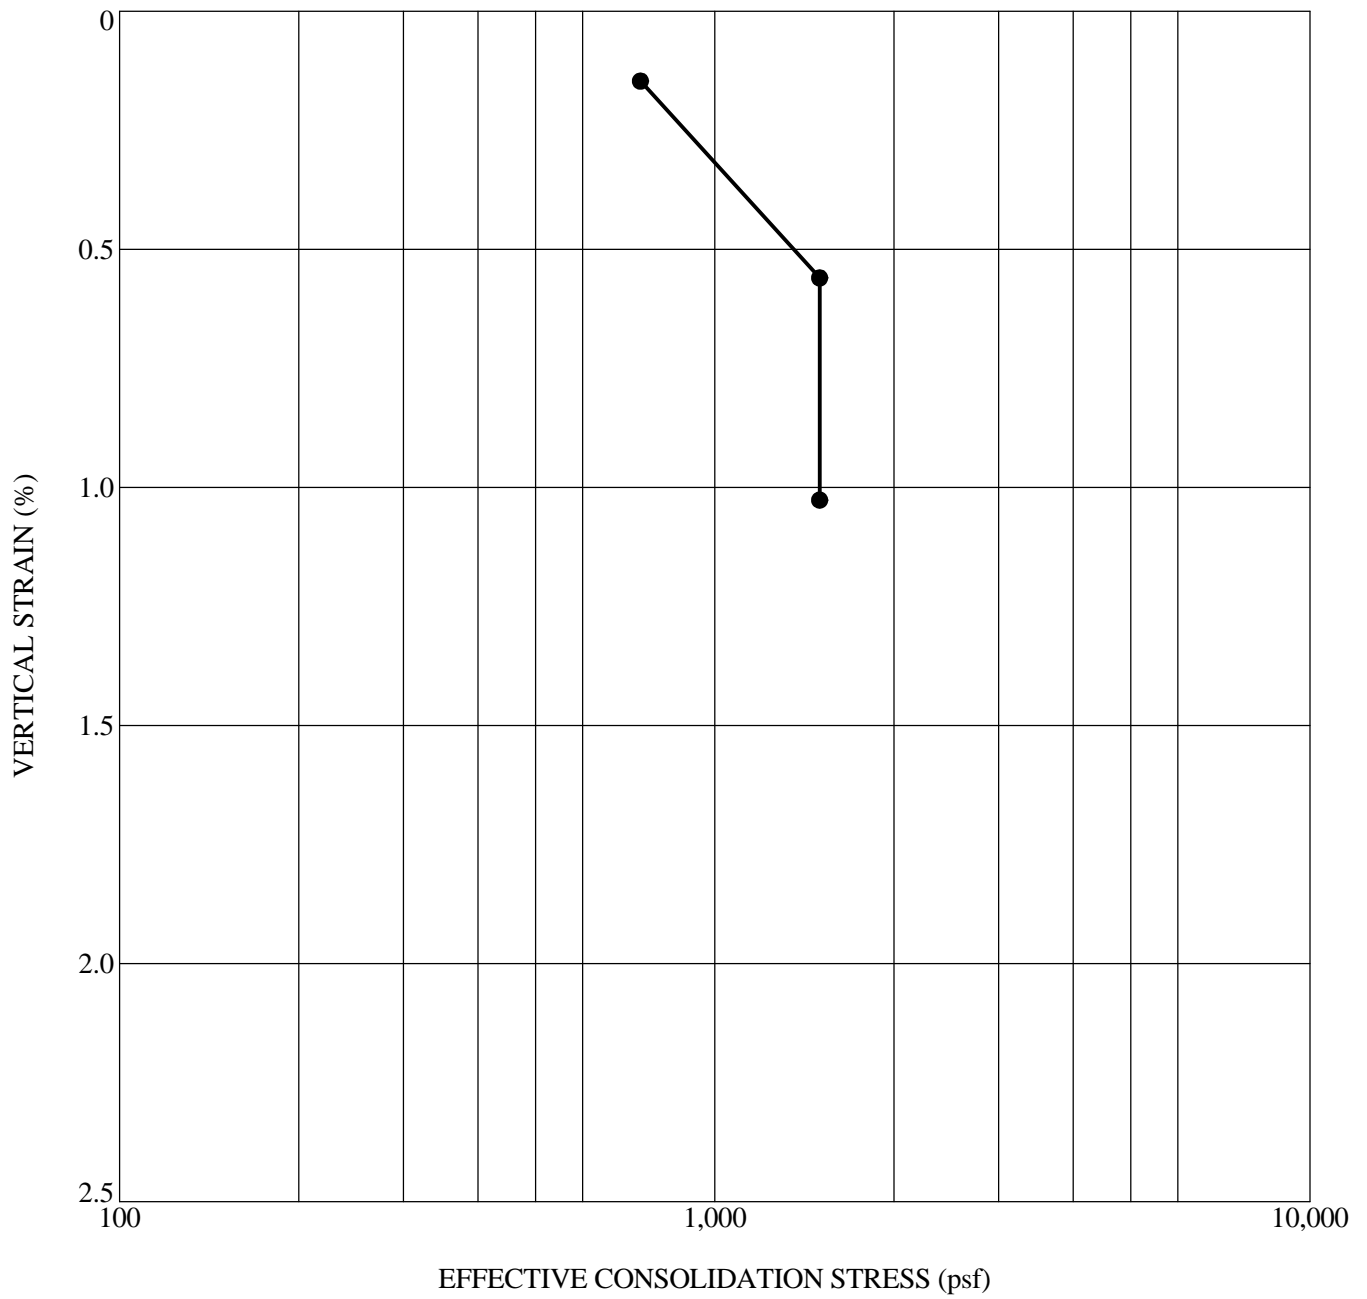
Plate
C - 15

Sample Location	Depth (ft)	Classification	γ_a (pcf)	MC (%)	C'_c	C'_r	OCR	Inundation Load (psf)	Swell (%)	Collapse (%)
● MW-TP-28	3.5	Sandy Silty CLAY	107	7				1500		0.47

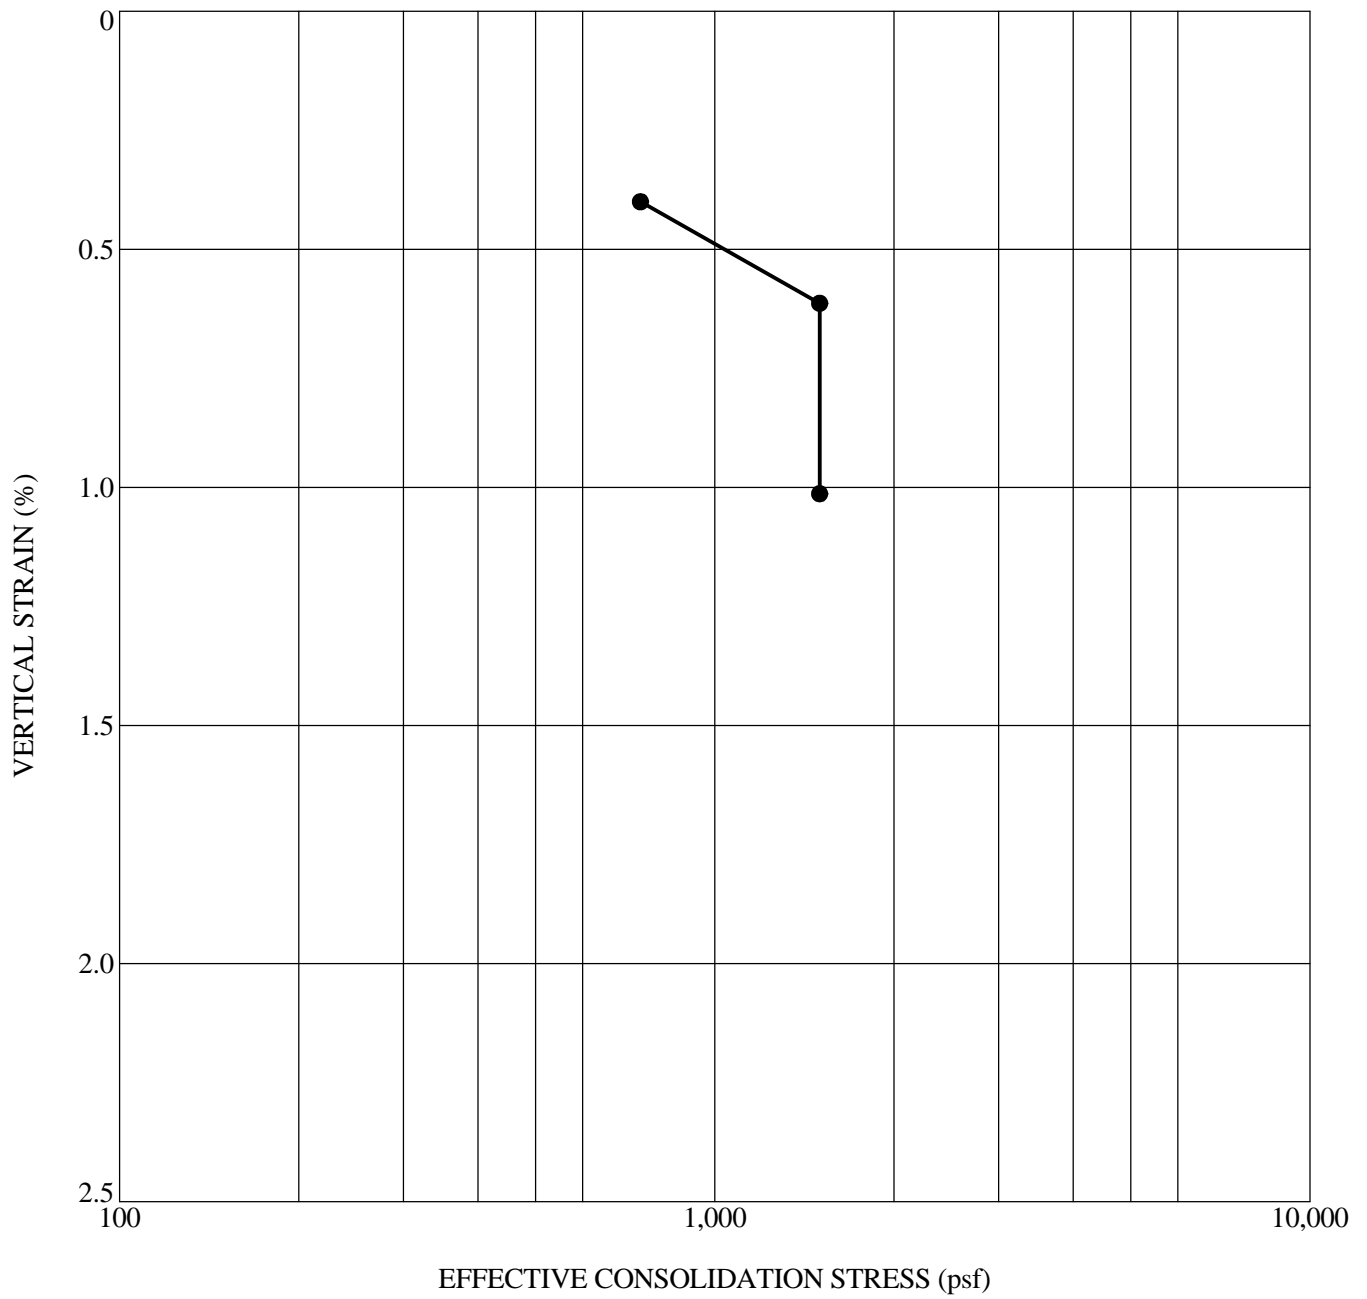
Plate
C - 16

Sample Location	Depth (ft)	Classification	γ_a (pcf)	MC (%)	C'_c	C'_r	OCR	Inundation Load (psf)	Swell (%)	Collapse (%)
● MW-TP-30	4.0	Lean CLAY	103	24				1500		0.40

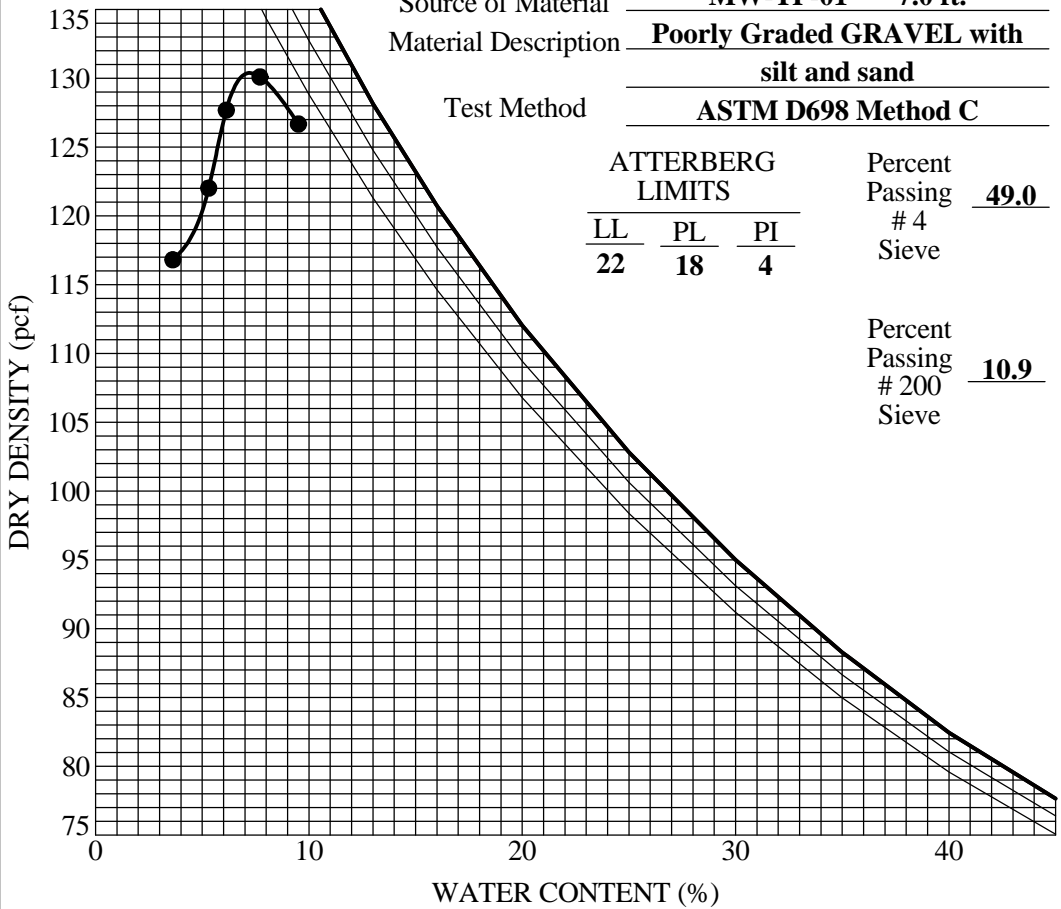
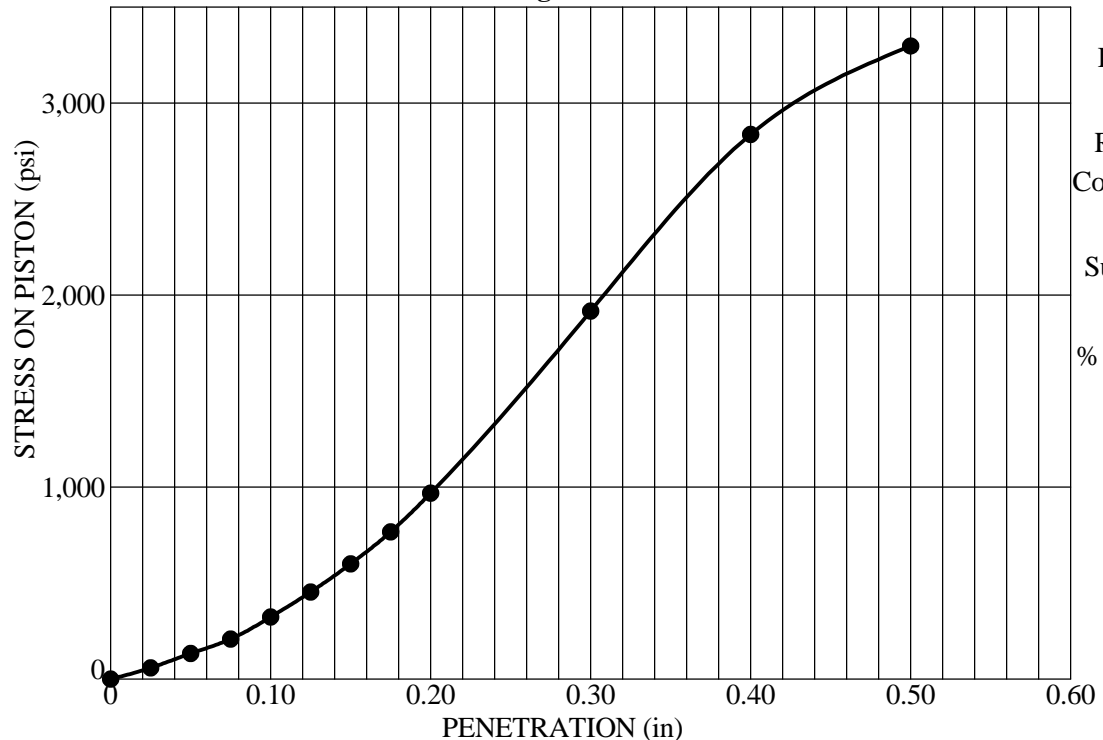
Plate
C - 17

TEST RESULTS	
Maximum Dry Density	<u>132.0 (pcf)</u>
Optimum Water Content	<u>7.0 (%)</u>
Percent Rock	<u>18.0 (%)</u>
Corrected Maximum Dry Density	<u>136.3 (pcf)</u>
Corrected Optimum Water Content	<u>6.1 (%)</u>

Curves of 100% Saturation for Specific Gravity Equal to:
2.60, 2.70, 2.80

Dry Density	<u>132.0 (pcf)</u>
Relative Compaction	<u>100 (%)</u>
Surcharge	<u>51 (psf)</u>
% Standard CBR	<u>76.70</u>
Swell	<u>-0.20 (%)</u>

COMPACTION AND CBR TEST

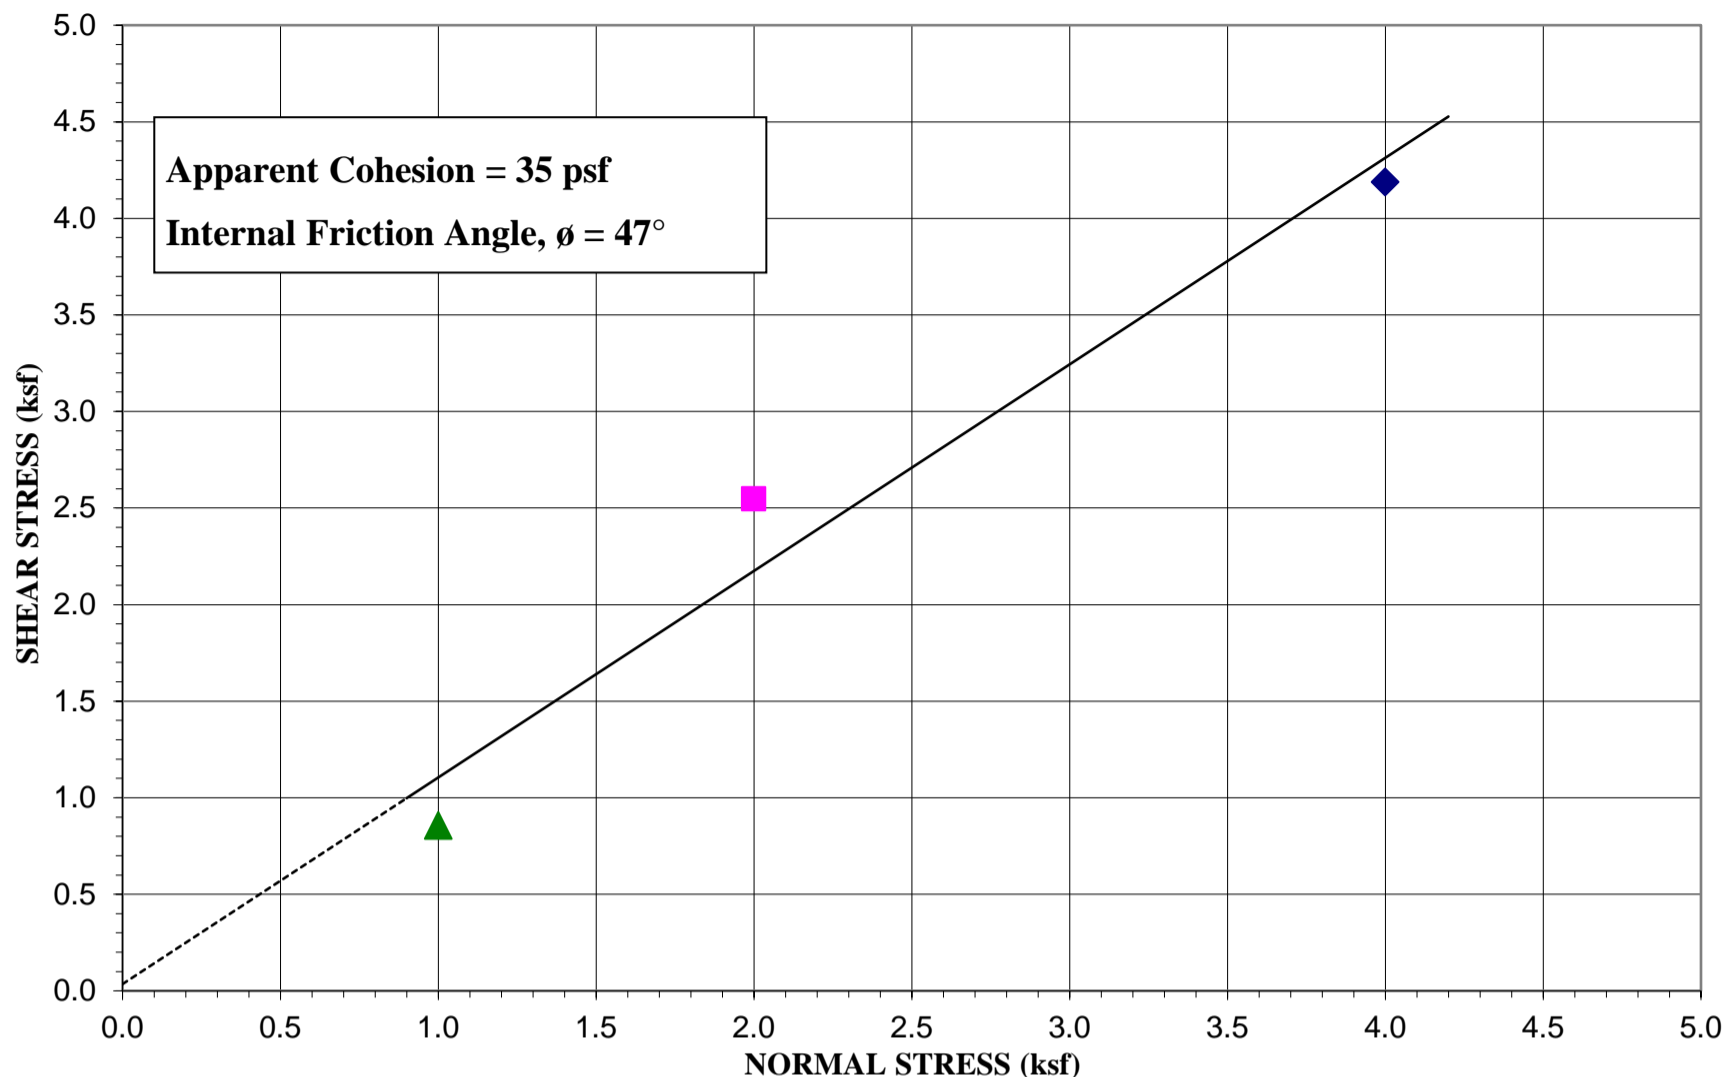
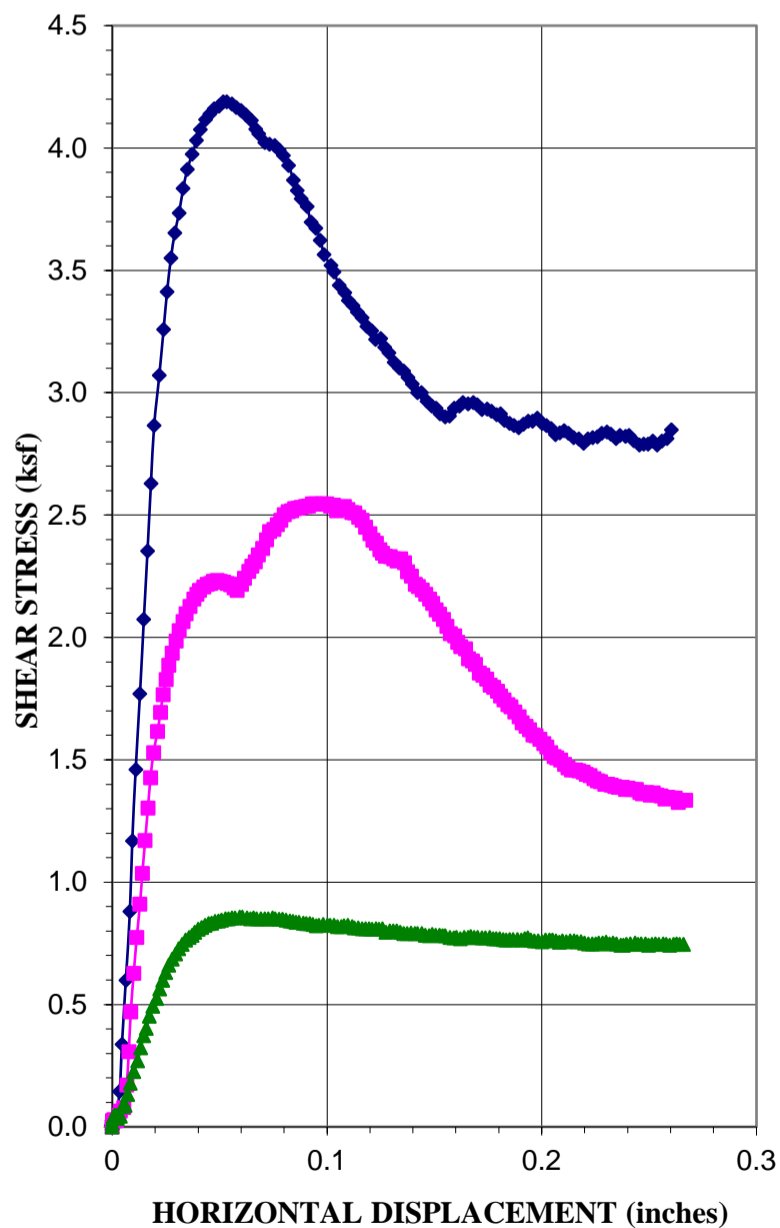
DIRECT SHEAR TEST

Source:	MW-TP-02 at 8 feet
Type of Test:	Consolidated Drained/Saturated

Test No. (Symbol)	1 (◆)	2 (■)	3 (▲)
Sample Type	Remolded		
Initial Height, in.	1.006	1.018	1.093
Diameter, in.	2.5	2.5	2.5
Dry Density Before, pcf	101.5	100.2	93.6
Dry Density After, pcf	103.3	102.0	95.2
Moisture % Before	8.4	11.2	8.6
Moisture % After	21.0	21.1	23.0
Saturation, % Before	35.1	45.7	29.8
Saturation, % After	92.6	90.0	82.7
Normal Load, ksf	4.0	2.0	1.0
Shear Stress, ksf	4.19	2.55	0.86
Strain Rate	0.00333 IN/MIN

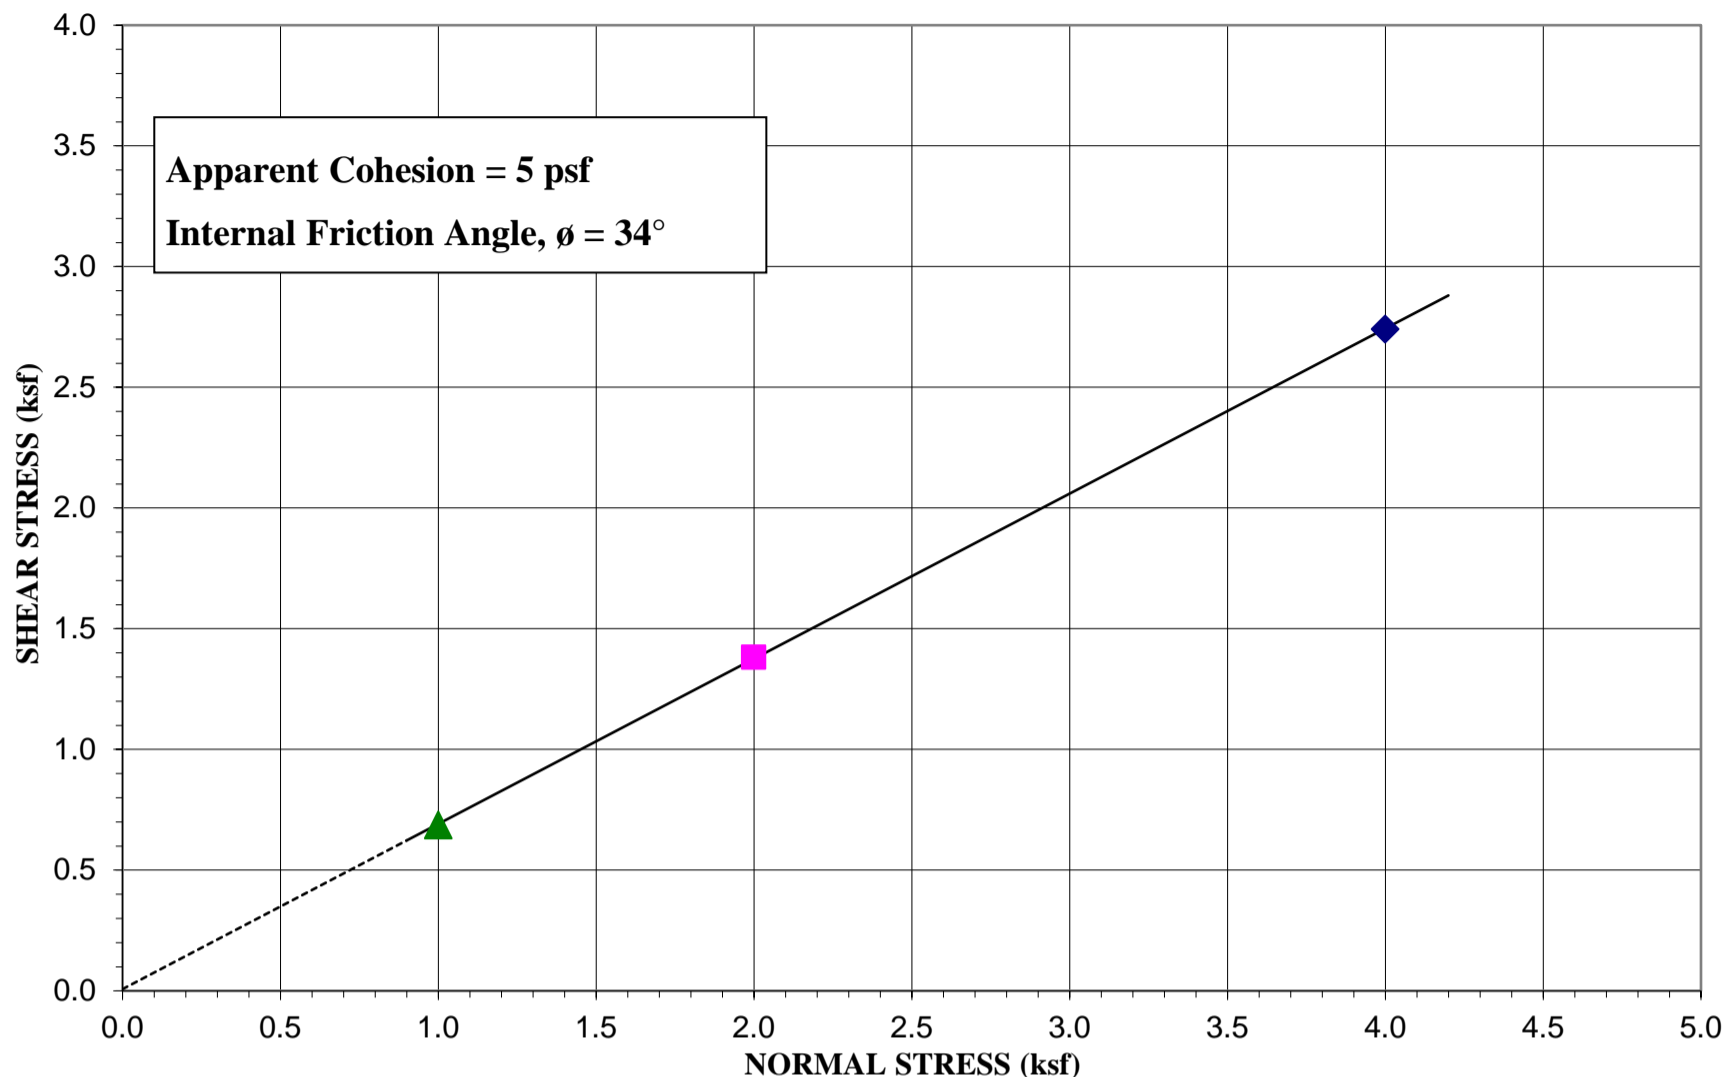
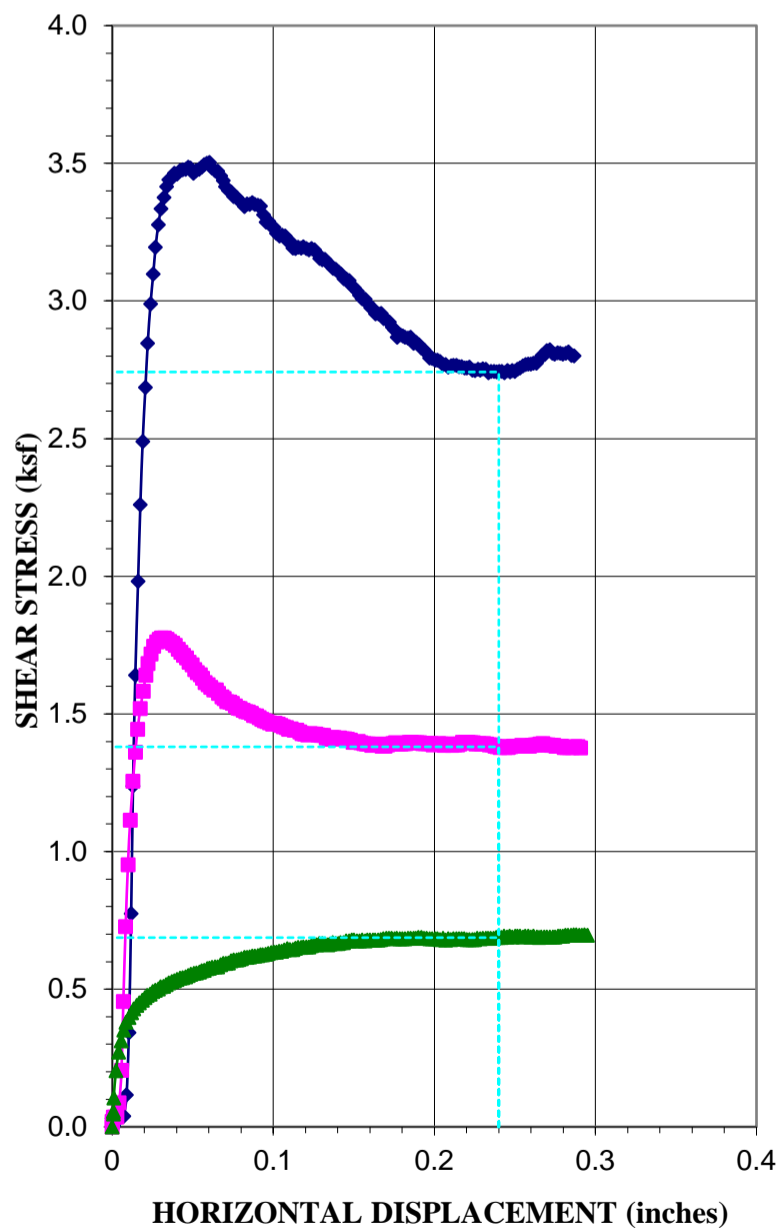
DIRECT SHEAR TEST

Sample Location:	MW-TP-11 at 6 feet
Type of Test:	Consolidated Drained/Saturated

Test No. (Symbol)	1 (◆)	2 (■)	3 (▲)
Sample Type	Remolded		
Initial Height, in.	0.829	0.835	0.949
Diameter, in.	2.5	2.5	2.5
Dry Density Before, pcf	118.8	118.0	103.1
Dry Density After, pcf	121.2	120.3	105.1
Moisture % Before	9.9	13.1	10.8
Moisture % After	15.7	16.5	19.2
Saturation, % Before	67.2	86.2	47.3
Saturation, % After	114.2	116.7	89.0
Normal Load, ksf	4.0	2.0	1.0
Shear Stress, ksf	2.74	1.38	0.69
Strain Rate	0.003333 IN/MIN
