Geotechnical Investigation
Skye Property – Inverness Area
Approximately 500 West and State Road 92
Lehi, Utah

January 31, 2023

GeoStrata Job No. 589-147

**Preliminary Geotechnical Investigation
Skye Property – Inverness Area
Approximately 500 West and State Road 92
Lehi, Utah**

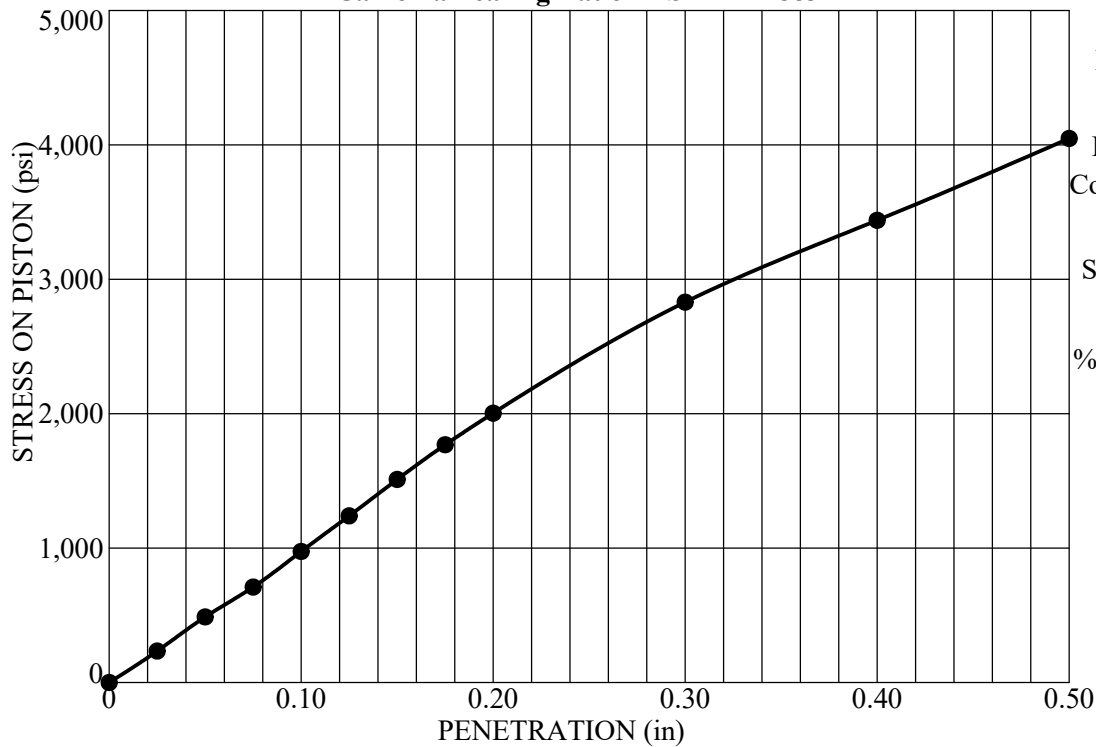
Plate
C - 10

| TEST RESULTS | |
| Maximum Dry Density | <u>130.8 (pcf)</u> |

California Bearing Ratio - ASTM D 1883

| Dry Density | <u>122.0 (pcf)</u> |
| Relative Compaction | <u>93 (%)</u> |

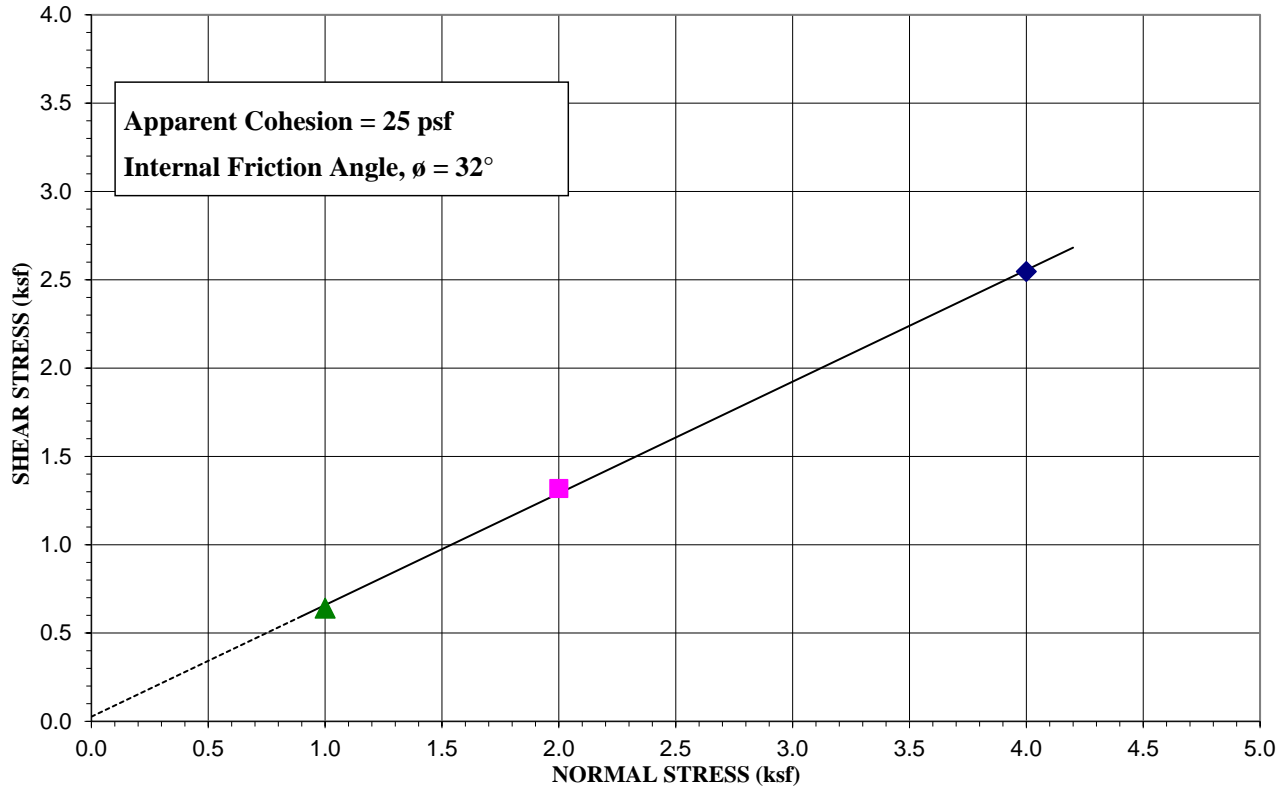
DIRECT SHEAR TEST

| Sample Location: | TP-16 @ 3 |
| Type of Test: | Consolidated Drained/Saturated |
